StEER
STRUCTURAL
EXTREME EVENTS
RECONNAISSANCE

LAGUNAS PERÚ MAY 26, 2019 EARTHQUAKE VIRTUAL ASSESSMENT STRUCTURAL TEAM (VAST) REPORT

Released: June 3, 2019 | **NHERI DesignSafe Project ID:** PRJ-2395

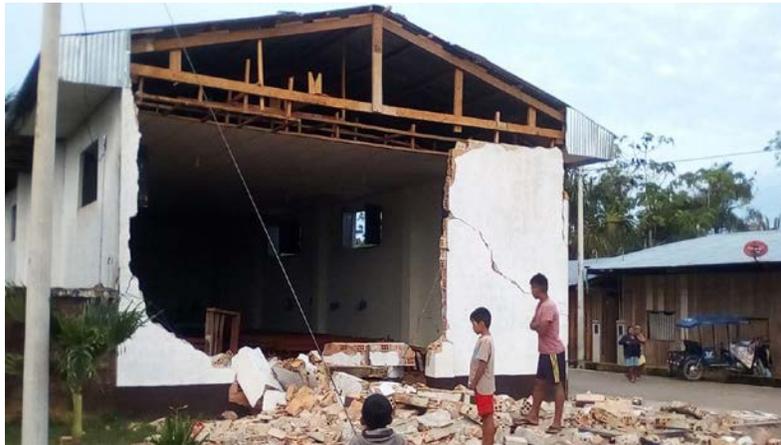
Earthquake damage in Santa Cruz, Alto Amazonas Province, Perú on May 26, 2019.
(Source: Rotafono [2])

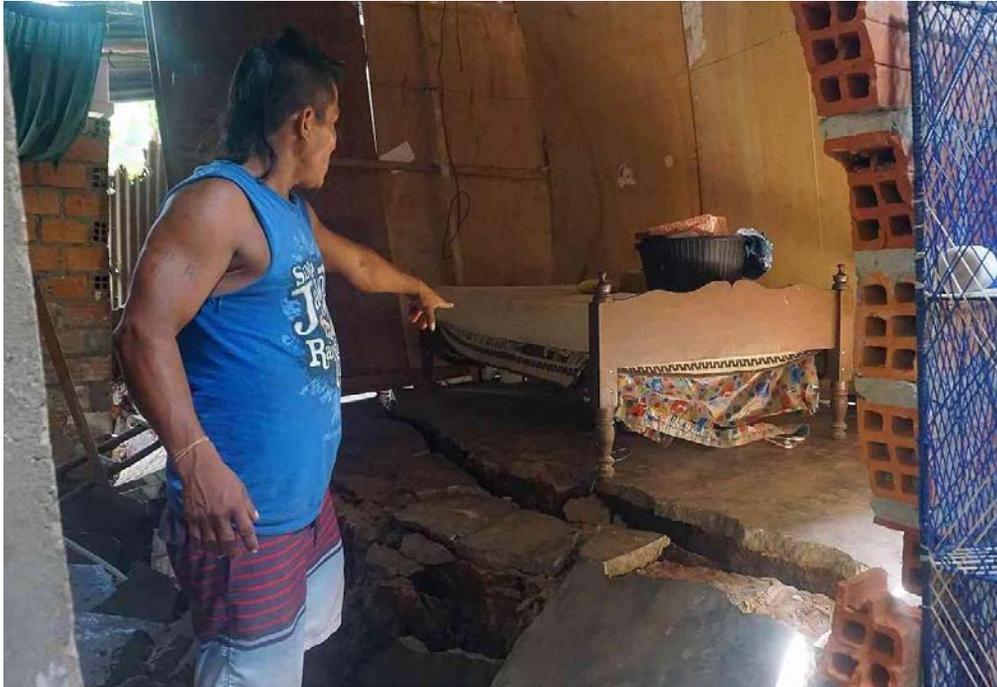
Figure 9.1. Ground failure inside family house in Alto Amazonas, Loreto (Source: AFP [3]).

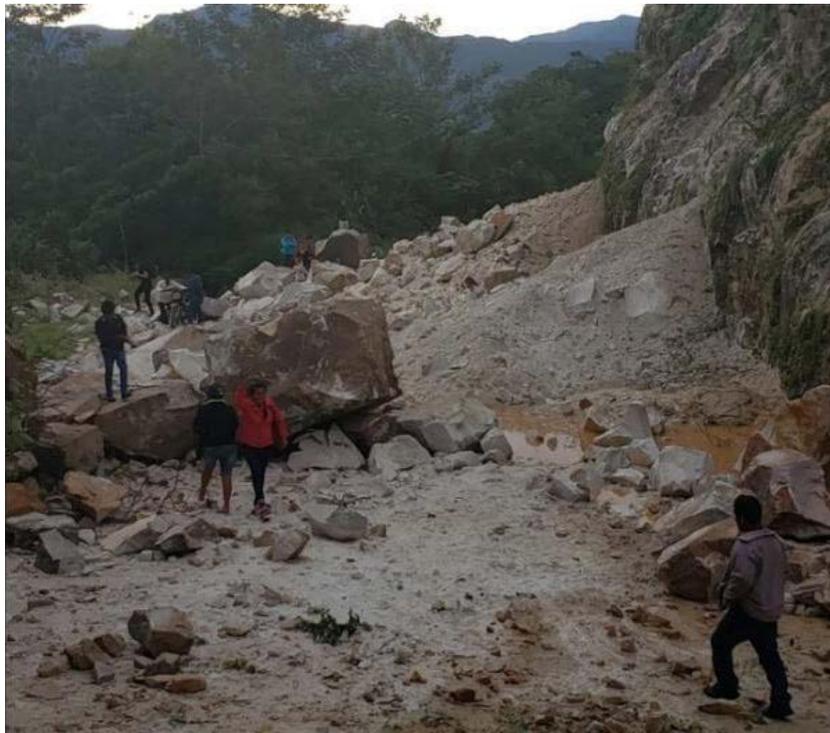
Figure 9.15. Landslide/rockfall-induced damage to the highway between Tarapoto and Yurimaguas (Holguin, 2019).

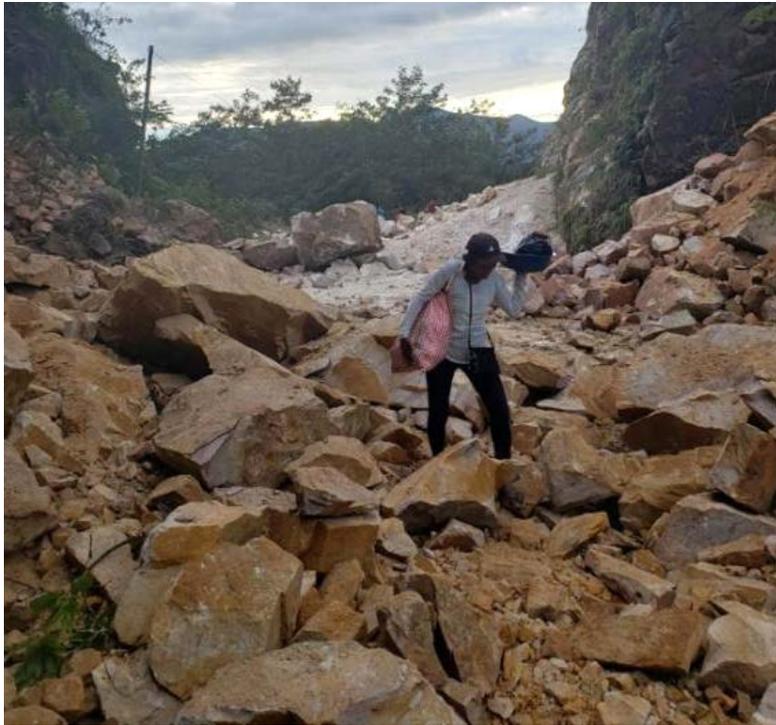
Figure 9.16. Damaged highway Tarapoto -Yurimaguas (Holguin, 2019).

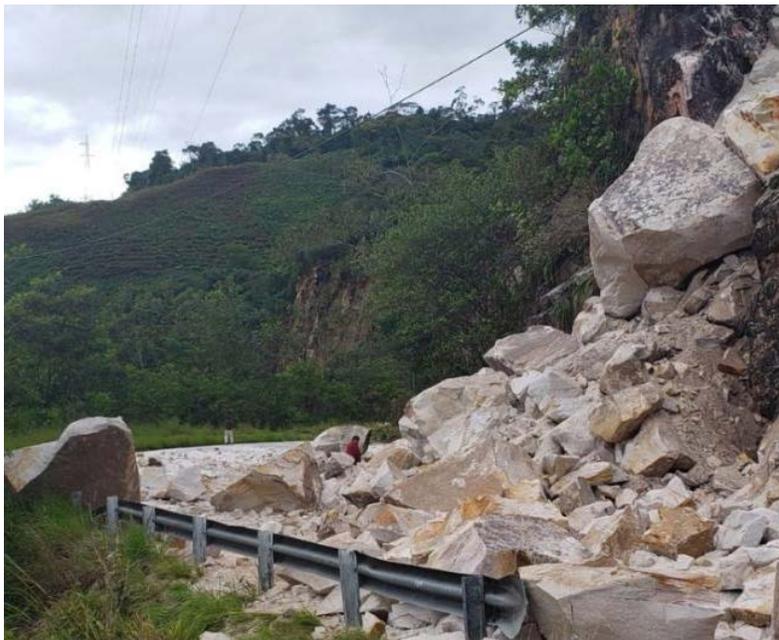
Figure 9.17. Rock slides, near Yurimaguas City, Loreto Region (Holguin, 2019).

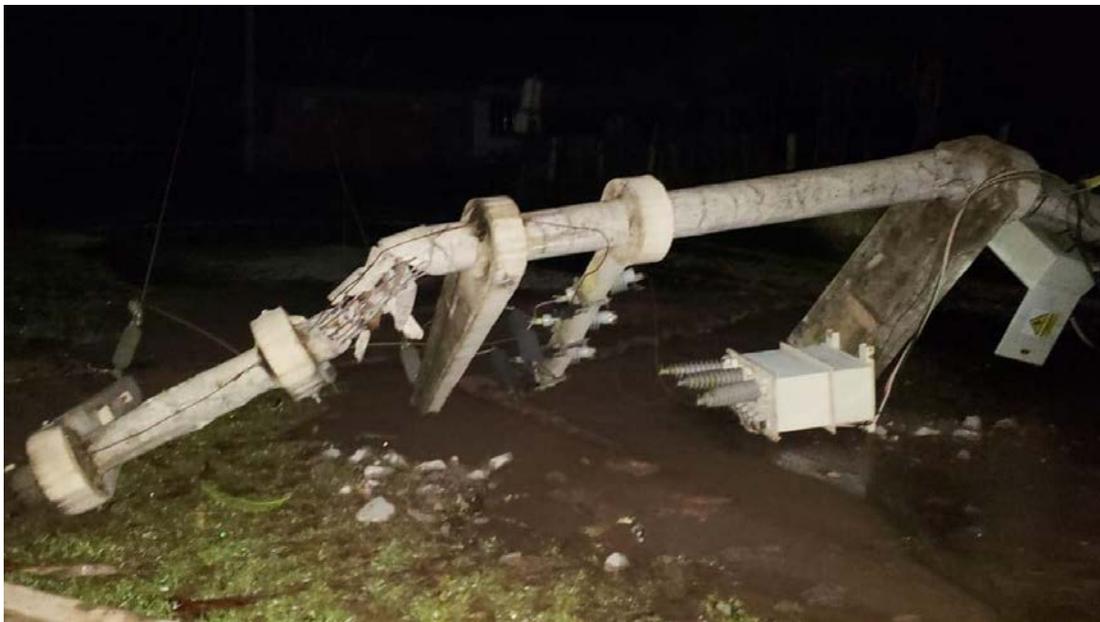
Figure 9.21. Damage to a power pole and electrical transformer caused by liquefaction at the Sauce district and Caserio 2 de Mayo in San Martin. (Source: Rotafono [2]).

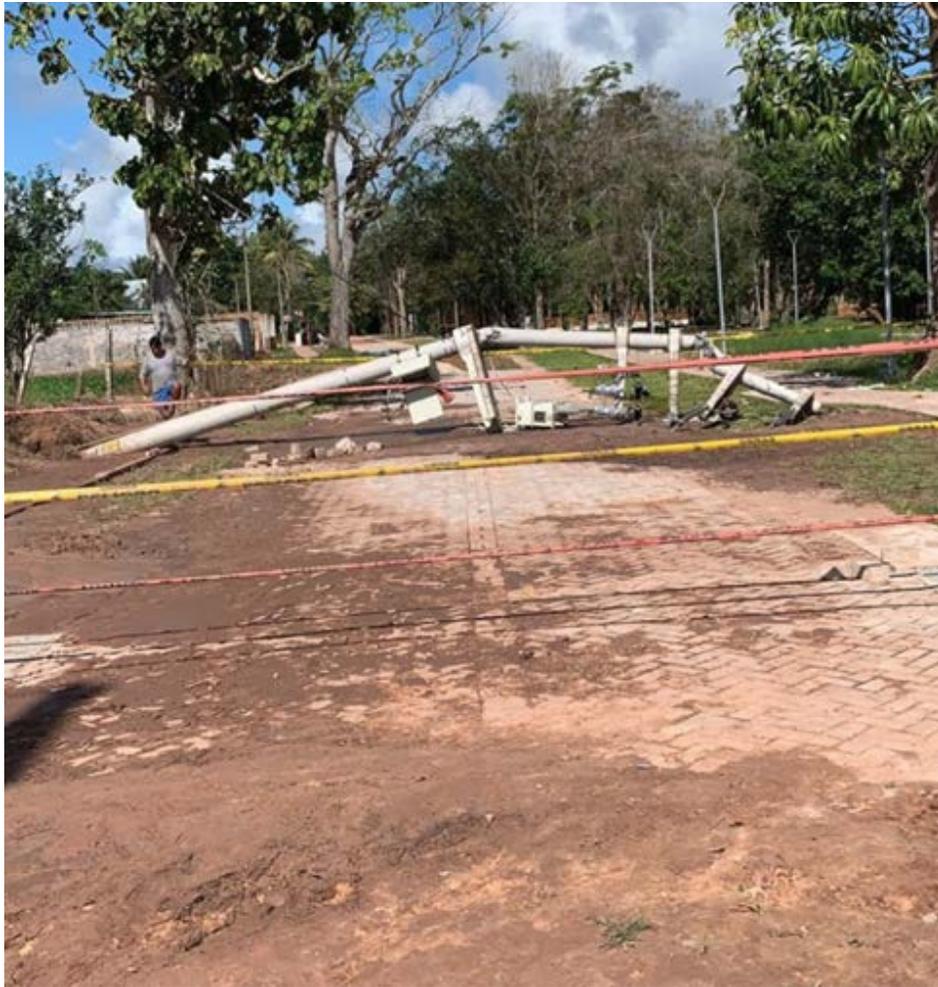
Figure 9.22. Collapse of a power pole and electrical transformer caused by liquefaction-induced failure of its footing foundation at the Sauce district and Caserio 2 de Mayo in San Martin. (Source: Rotafono [2]).

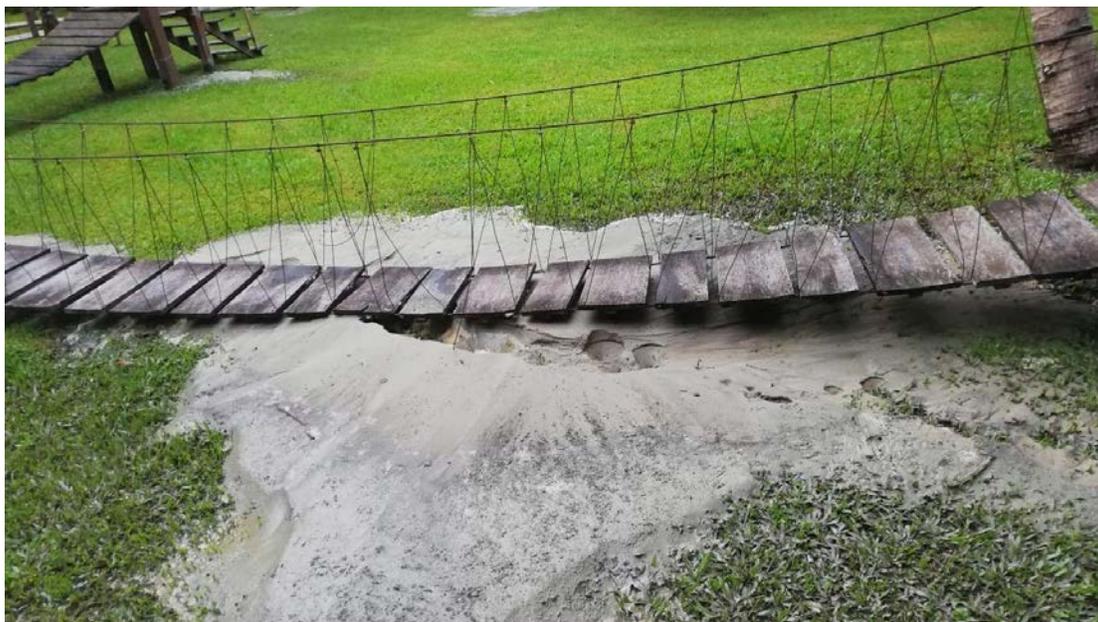
Figure 9.23. Liquefaction ejecta in El Sauce Resort, Tarapoto. (Source: Rotafono [2]).

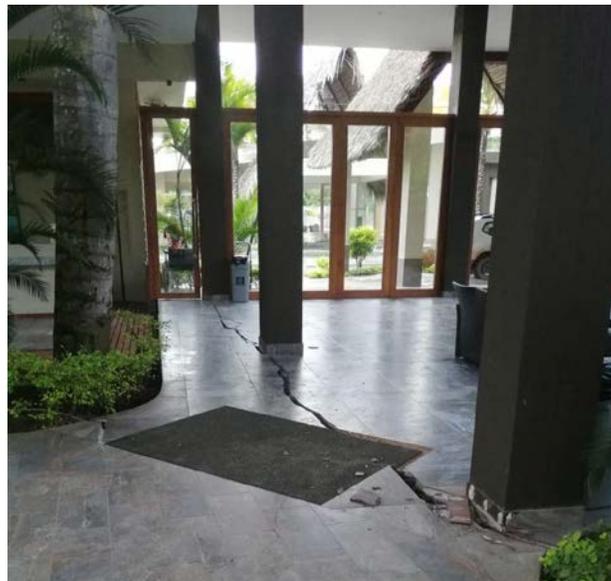
Figure 9.25. Failure of the slab-on-grade at El Sauce Resort, Tarapoto (Source: Rotafono [2]).

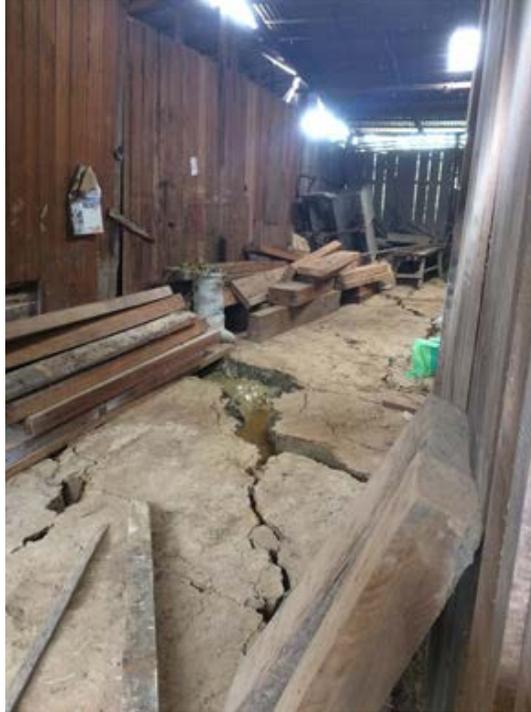
Figure 9.26. Seismically-induced ground damage due to apparent liquefaction and lateral spreading at El Sauce District (Source: Ministerio de Vivienda del Perú - Photo by Miguel Estrada).

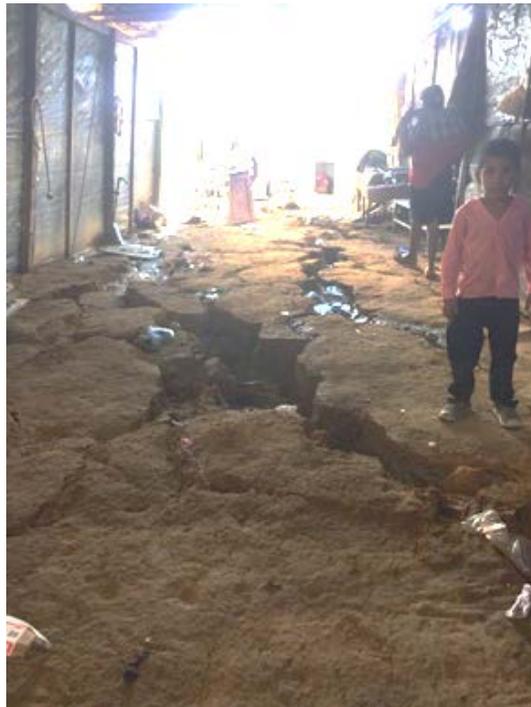
Figure 9.27. Seismically-induced ground damage due to apparent liquefaction and lateral spreading at El Sauce District (Source: Ministerio de Vivienda del Perú - Photo by Miguel Estrada).

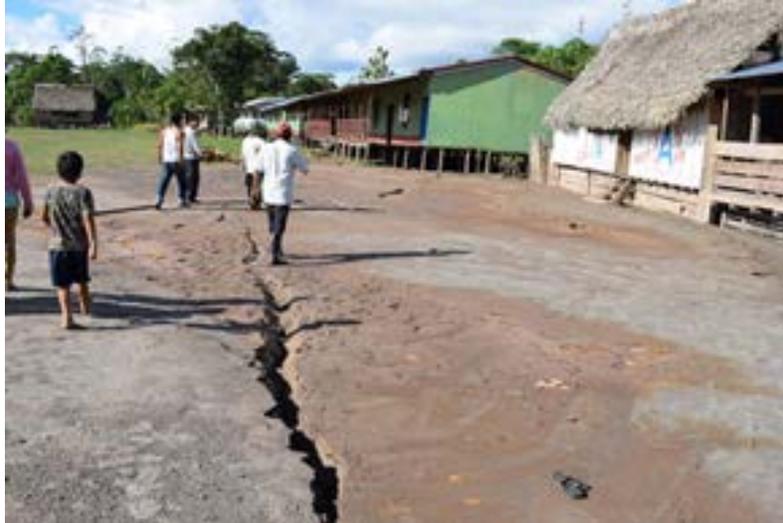
Figure 9.28. Seismically-induced ground damage due to liquefaction and lateral spreading at El Sauce District (Source: Ministerio de Vivienda del Perú - Photo by Miguel Estrada).

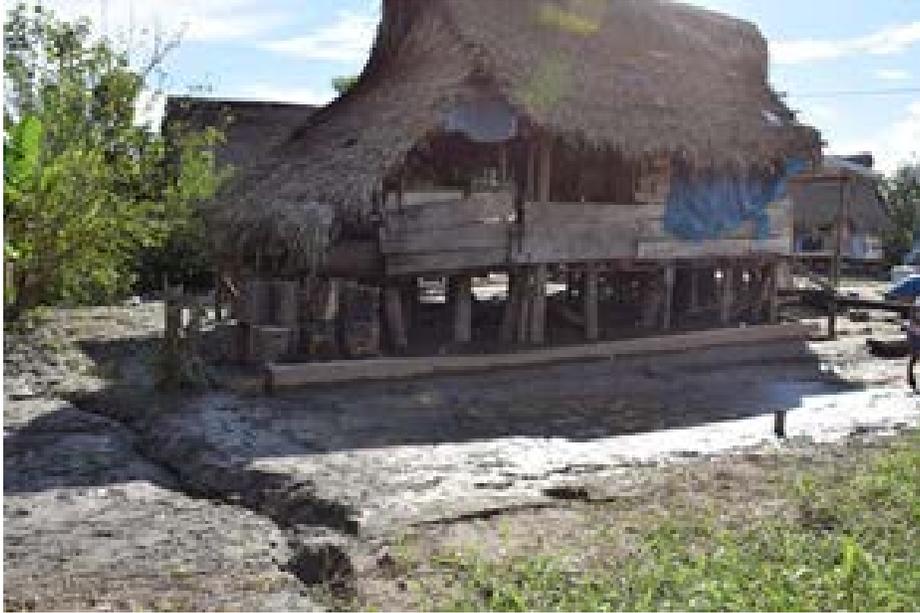
Figure 9.30. Seismically-induced ground damage due to liquefaction and lateral spreading at El Sauce District (Source: Ministerio de Vivienda del Perú - Photo by Miguel Estrada).

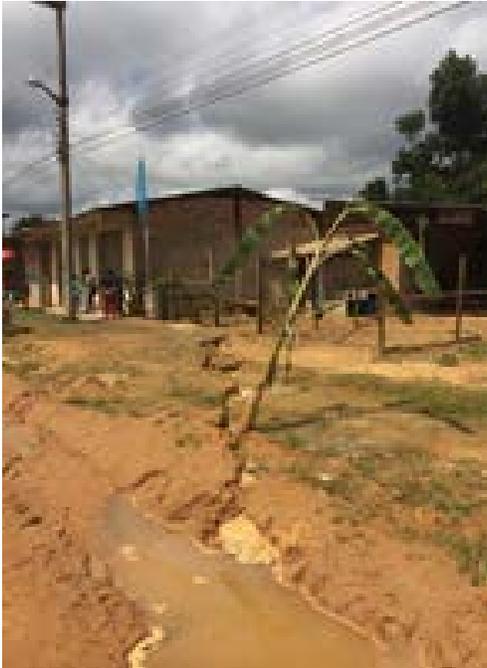
Figure 9.31. Seismically-induced ground damage due to apparent liquefaction and lateral spreading at El Sauce District (Source: Ministerio de Vivienda del Perú - Photo by Miguel Estrada).

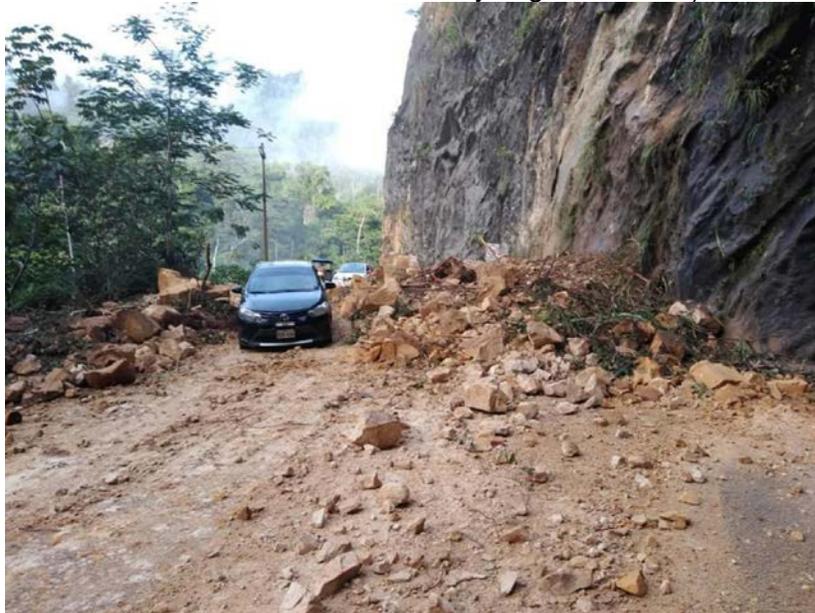
Figure 9.33. Yurimaguas-Tarapoto road, hill landslides (Source: @govanniacate via Twitter).

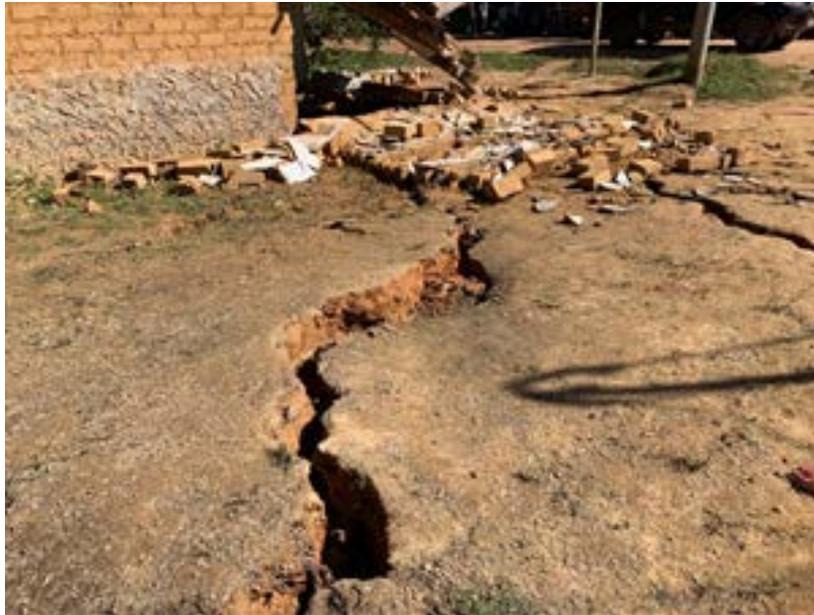
Figure 9.40. Apparent lateral spreading damage in buildings at the 2 de Mayo village, Yurimaguas. (Reategui and Mora, 2019).

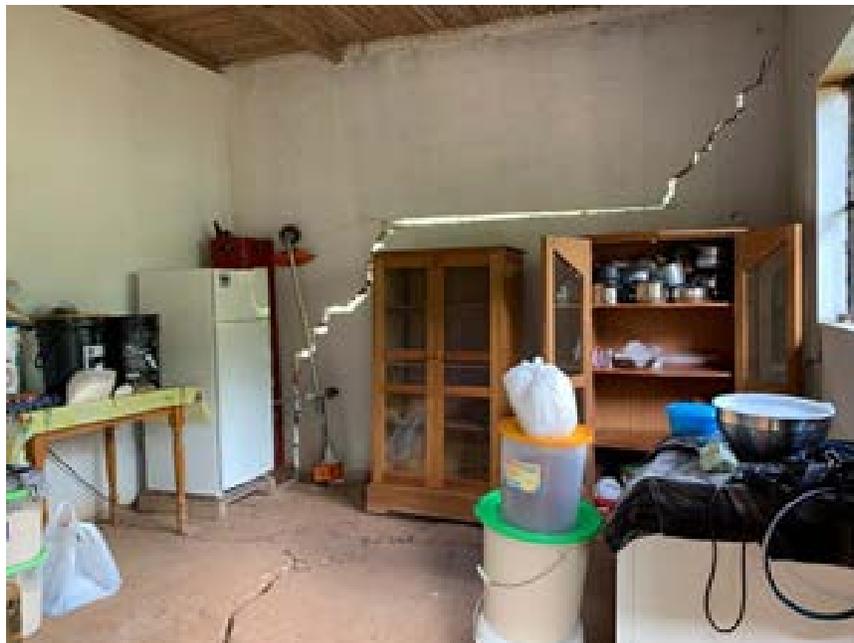
Figure 9.41. Severe damage in residential construction caused by ground deformations at the 2 de Mayo village, Yurimaguas (Reategui and Mora, 2019).

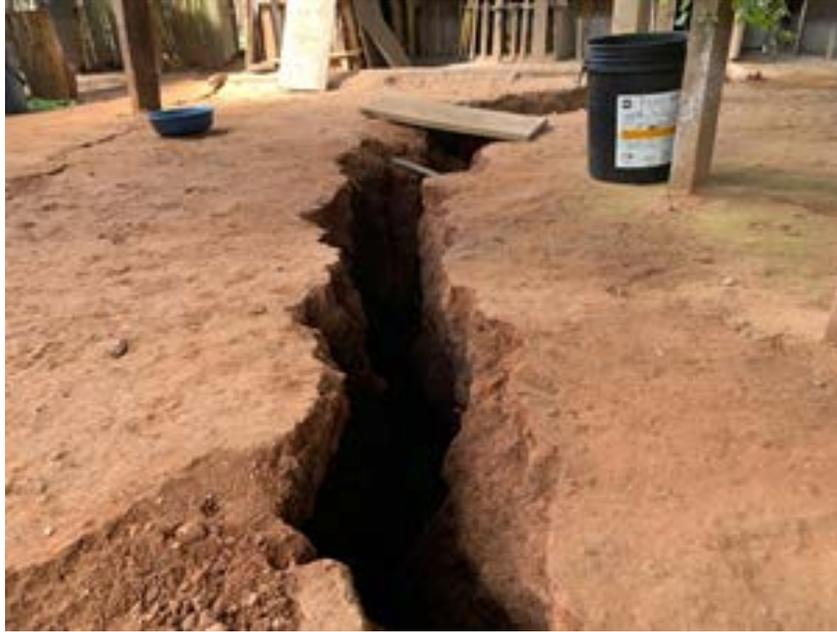
Figure 9.42. Apparent lateral spreading damage at the ground floor inside of a building at the 2 de Mayo village, Yurimaguas (Reategui and Mora, 2019).

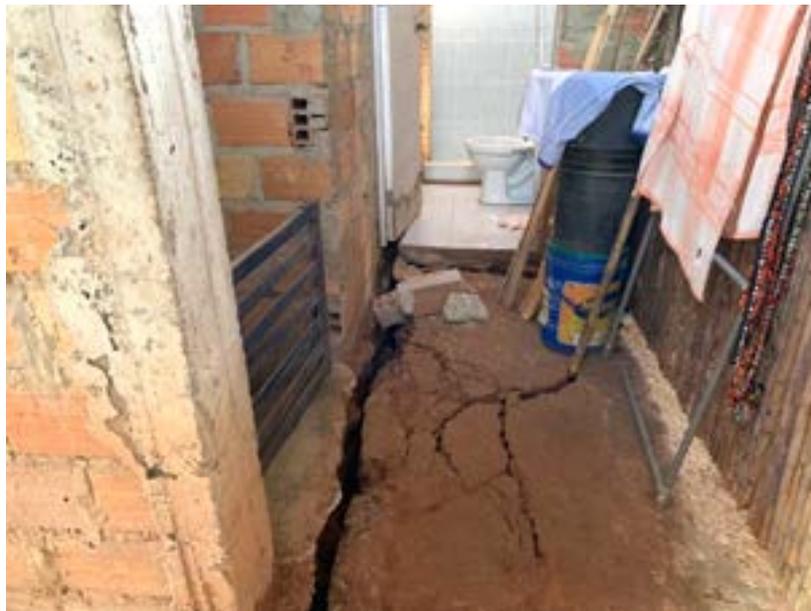
Figure 9.43. Apparent lateral spreading damage in buildings at the 2 de Mayo village, Yurimaguas (Reategui and Mora, 2019).

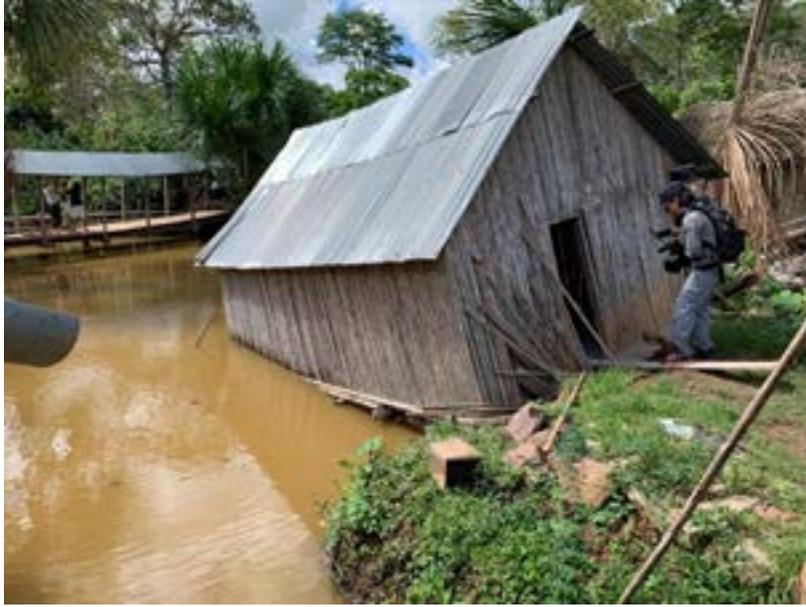
Figure 9.44. Apparent liquefaction-induced effects in buildings located at the 2 de mayo village, Yurimaguas (Reategui and Mora, 2019).

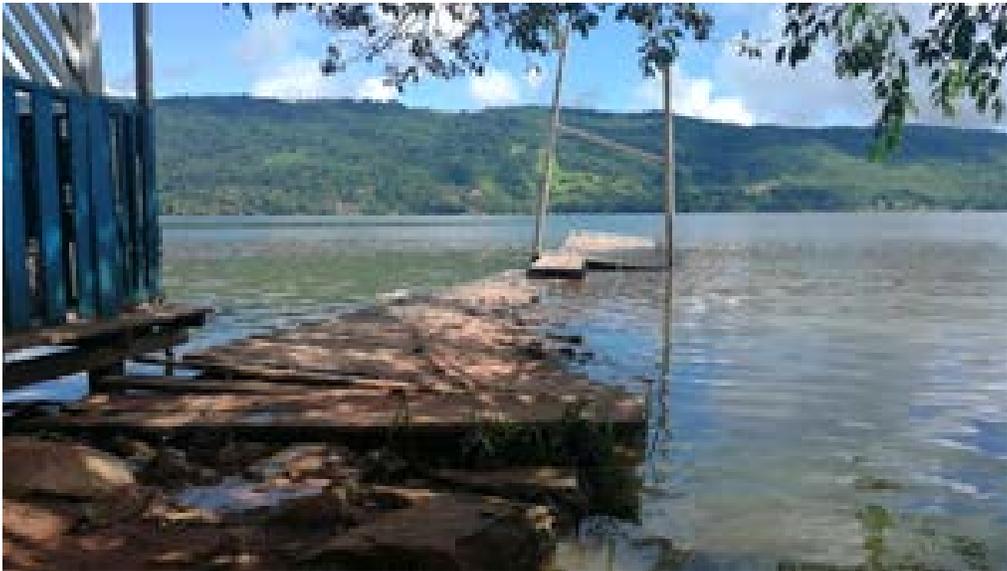
Figure 9.45. Failure of a wharf structure along the Huallaga river near Yurimaguas (Reategui and Mora, 2019).

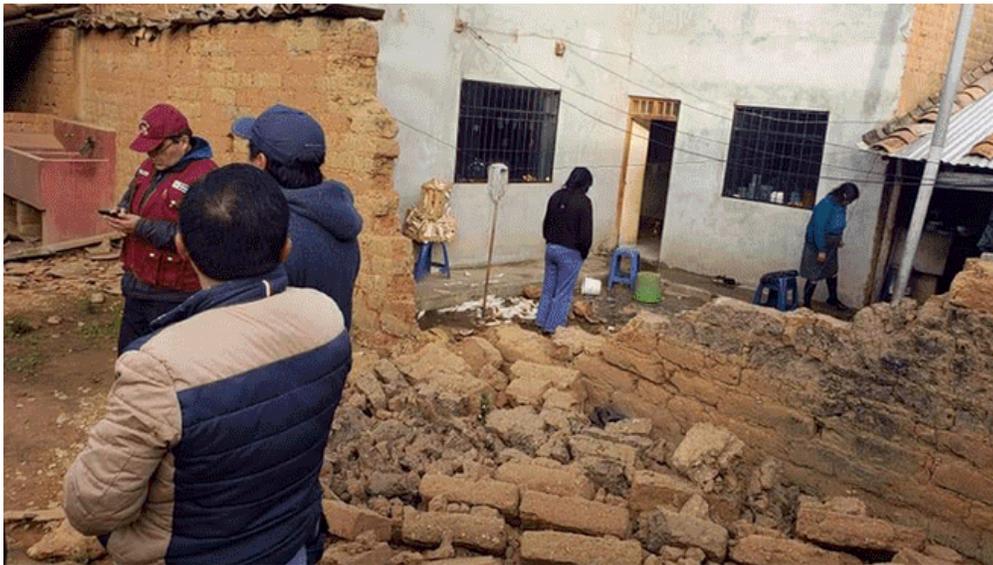
Consistent with post-earthquake field observations from past Peruvian earthquakes, and other earthquake-prone regions in developing countries, housing dwellings built with adobe suffered severe damage (Figure 9.46). Typical failure modes observed in the dwellings included vertical cracking at the corners of the house, which typically then leads to out-of-plane failures of the adobe walls. Traditionally, adobe walls do not have any type of vertical and horizontal reinforcement and have extremely low shear and lateral deformation capacity. Another structural deficiency is that roofs usually support heavy clay tiles that are prone to collapse as shown in Figures 9.47 and 9.48. Some housing dwellings in the affected region were built using hollow clay brick masonry walls, which also suffered structural damage. Some of this damage was produced by diagonal tension cracking which in some cases lead to out-of-plane failure of the walls as shown in Figure 9.49. In some cases collapse of corner adobe was observed at dwellings and buildings as shown in Figure 50 and 51. Figure 9.52 shows debris caused by the collapse of a parapet in a corner two-story adobe building in Yurimaguas City.

Figure 9.46. Collapse of old-housing dwelling built of adobe brick units in Huamachuco (Source: Diario La República [4]).

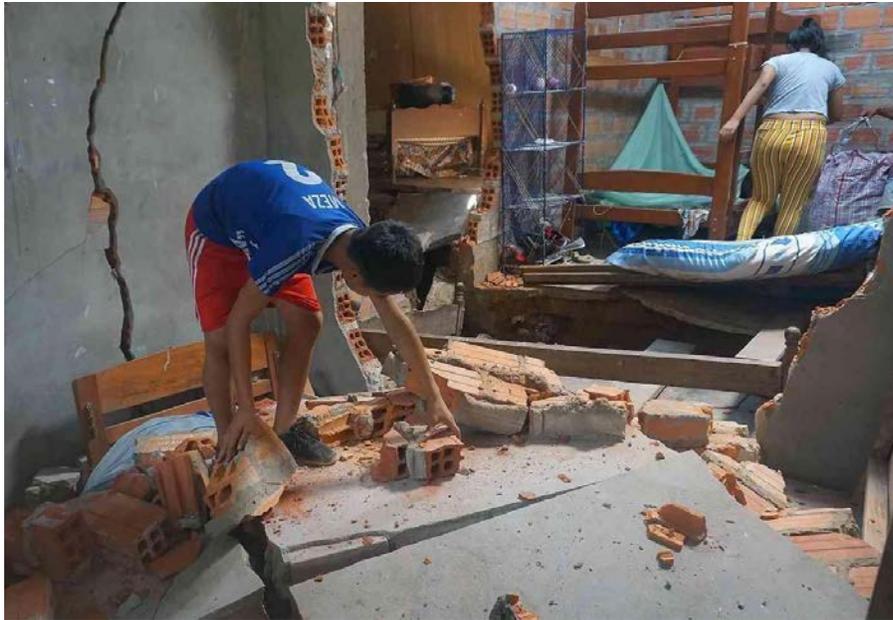
Figure 9.49. Out-of-plane failure of an interior hollow-clay brick masonry wall in Alto Amazonas, Loreto (Source: AFP [3]).

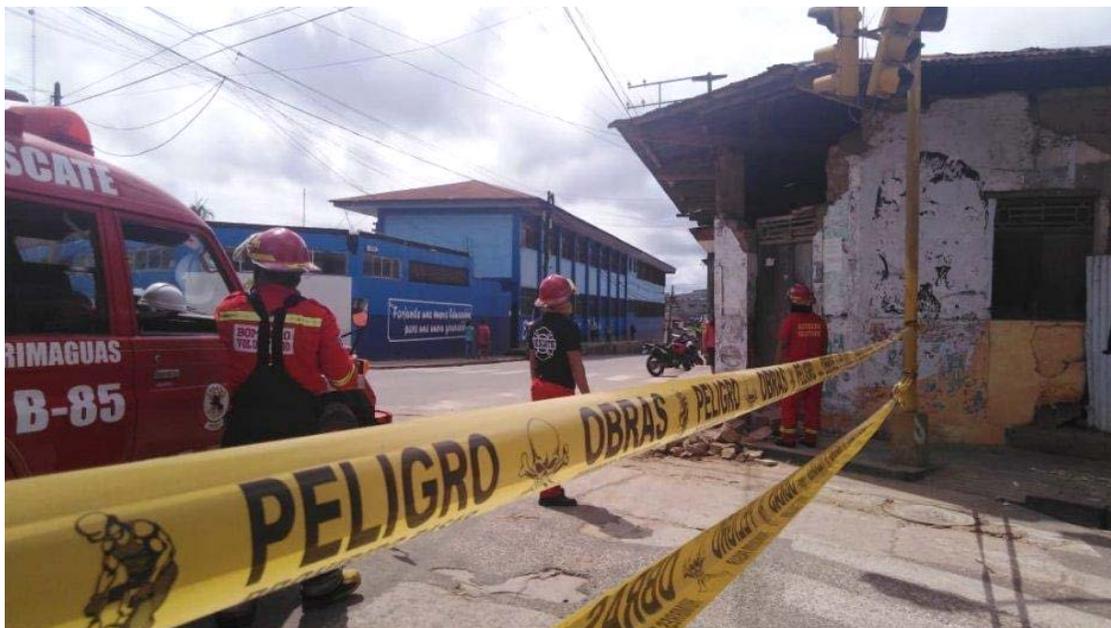
Figure 9.50. Damaged to adobe building in Alto Amazonas, Loreto (Holguin, 2019).

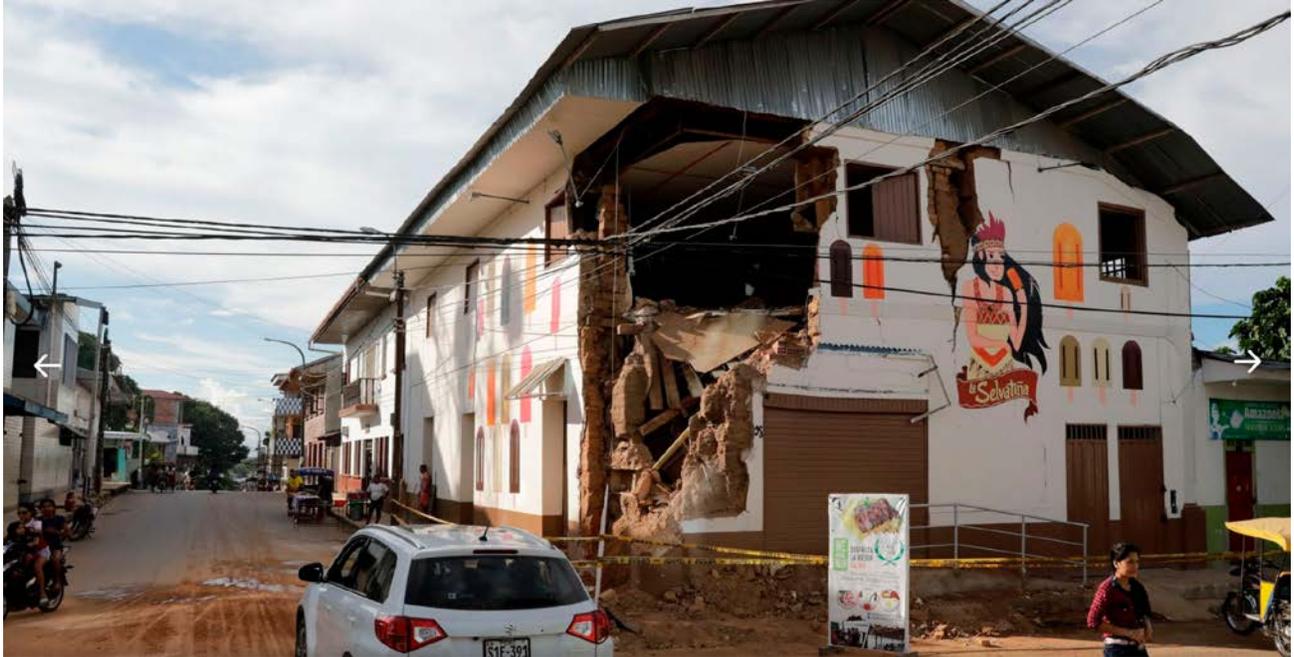
Figure 9.51. Partial collapse of a two-story adobe building in Yurimaguas, Perú (Holguin, 2019).

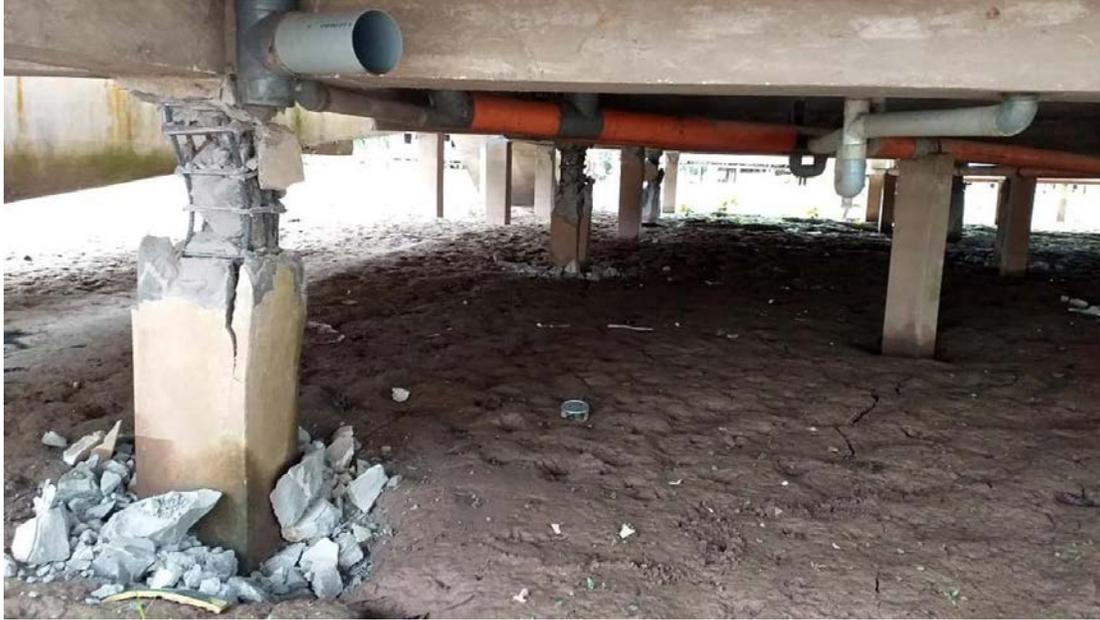
At the time of writing this report, there were very few cases of damage in reinforced concrete buildings. One exception is shown in Figure 9.53 which displays severe structural damage due to shear failure in relatively short and poorly detailed reinforced concrete columns.

Figure 9.53. Shear failure in short foundation columns of a reinforced concrete building (Source: Rotafono [2]).

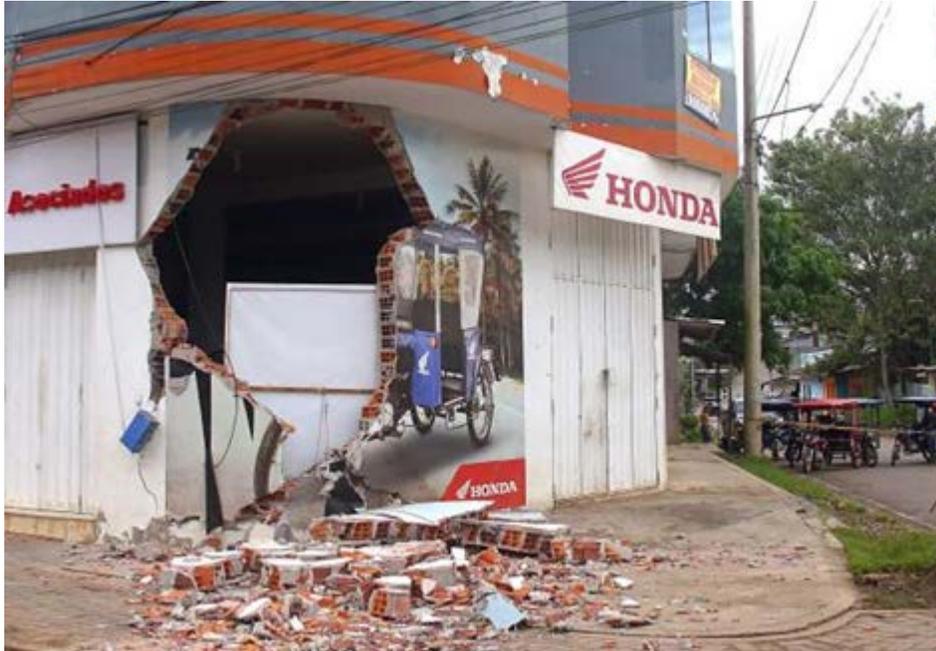
The strong earthquake also affected commercial buildings. For instance, a two-story corner building built of hollow-clay masonry bricks suffered damage as shown in Figure 9.54. The cracking pattern indicates that the out-of-plane failure of this masonry wall was likely preceded by diagonal tension cracking in the masonry wall.

Figure 9.54. Out-of-plane failure of a masonry infill wall in a commercial building located in Yurimaguas (Source: AFP [3]).

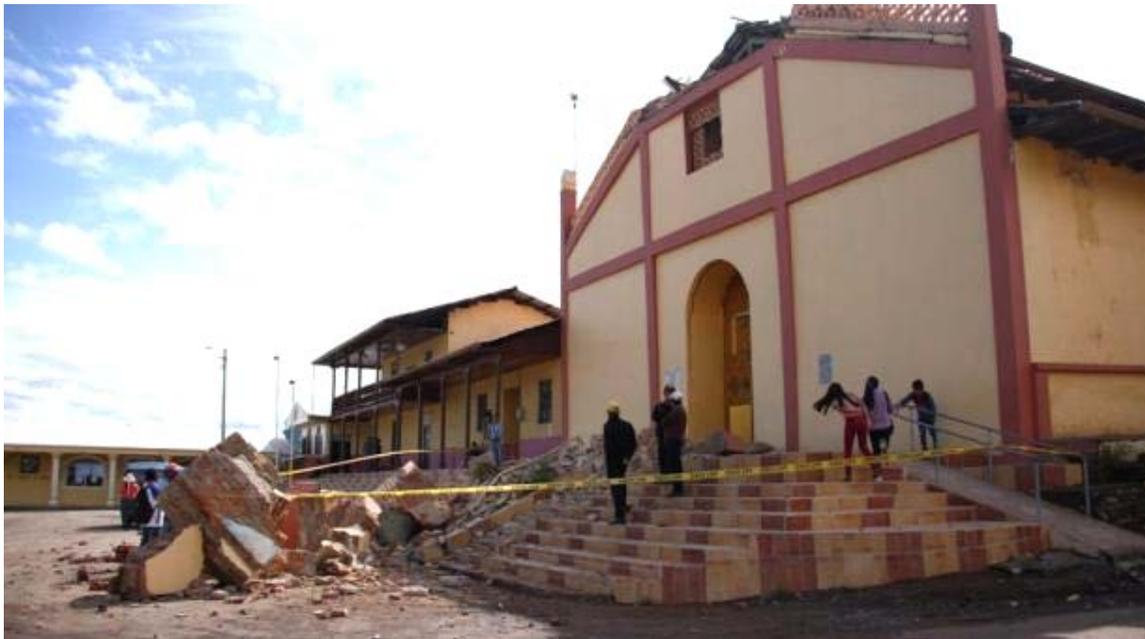
The earthquake resulted in the collapse of 5 churches and produced damage in 15 other churches. Figures 9.55 and 9.56 show part of a heritage church bell tower that collapsed in the town of Nambacola in the province of Loja. Nambacola is located at 56 km to the southwest of Loja city, the capital of the province of Loja. Loja city is located about 490 km from the epicenter. The church presents some cracking, and the bells that dated from 1901 were destroyed when the bell tower of the church collapsed. This structure was registered as part of the Cultural Heritage since 2015.

Figure 9.55. Bell tower of a church collapsed in Loja, Ecuador, at 490 km away from the epicenter (Trujillo, 2019).

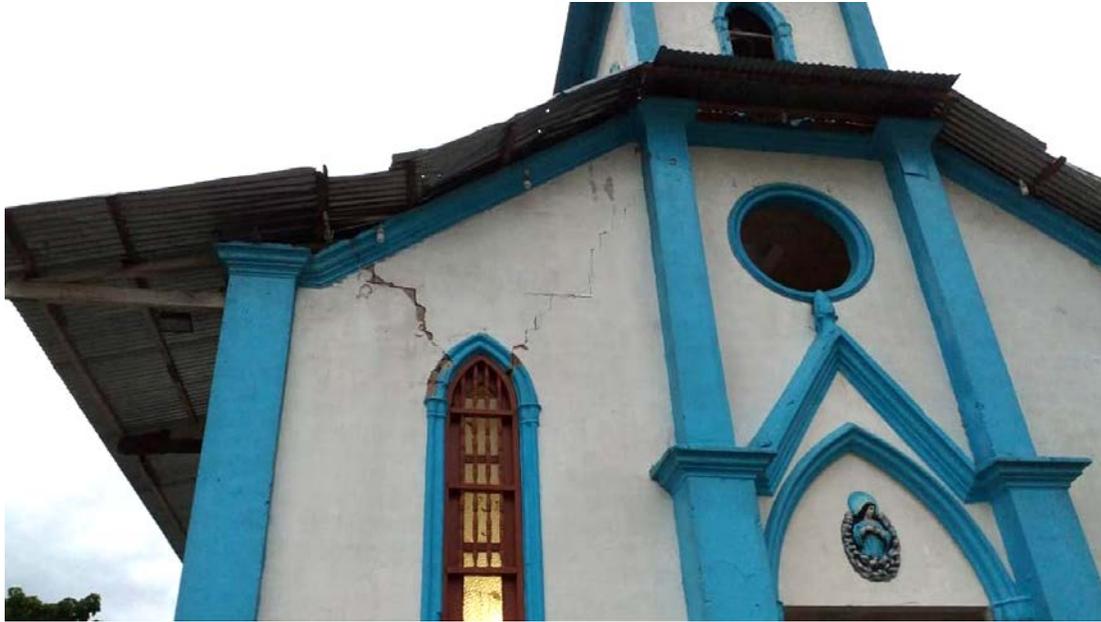
Figure 9.59. Diagonal cracking in the facade of a church after the earthquake at Alto Amazonas province, in the Loreto region (Source: Rotafono [2]).

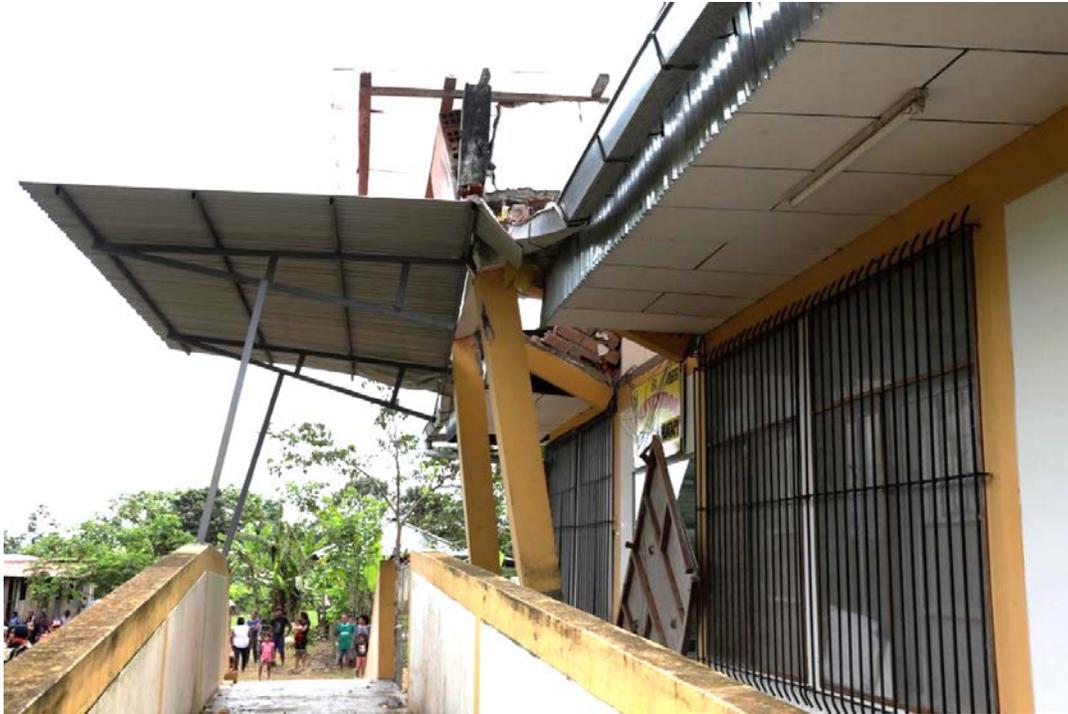
Figure 9.60. General structural damage in a healthcare facility in Huatapi, near Yurimaguas, in the Amazon region of Perú (Jourdan et al. 2019).

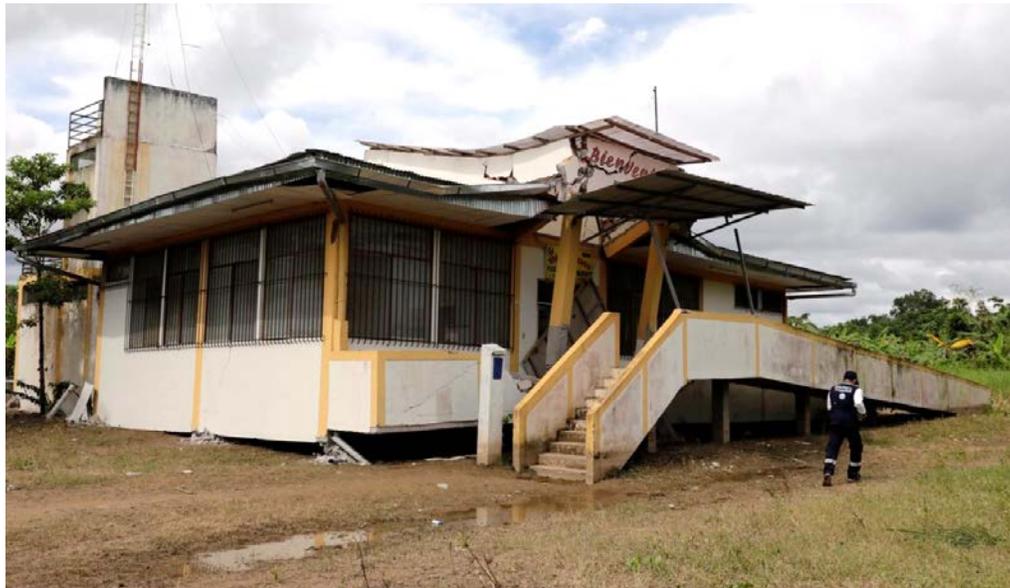
Figure 9.61. General structural damage in a healthcare facility in Huatapi, near Yurimaguas, in the Amazon region of Perú (Jourdan et al. 2019).

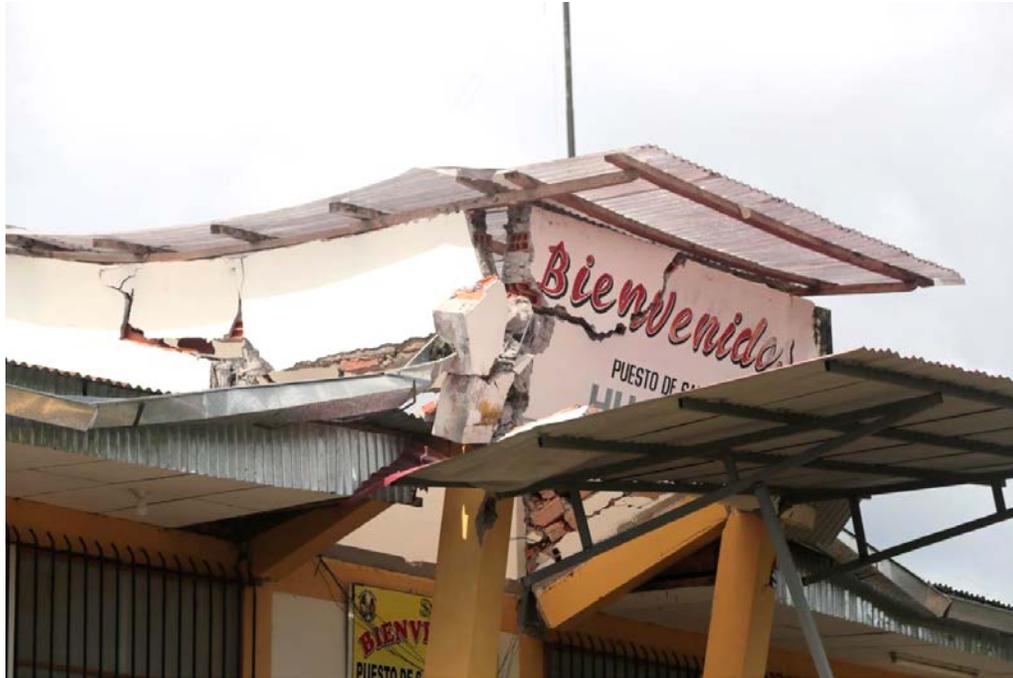
Figure 9.62. General structural damage in a healthcare facility in Huatapi, near Yurimaguas, in the Amazon region of Perú (Jourdan et al. 2019).

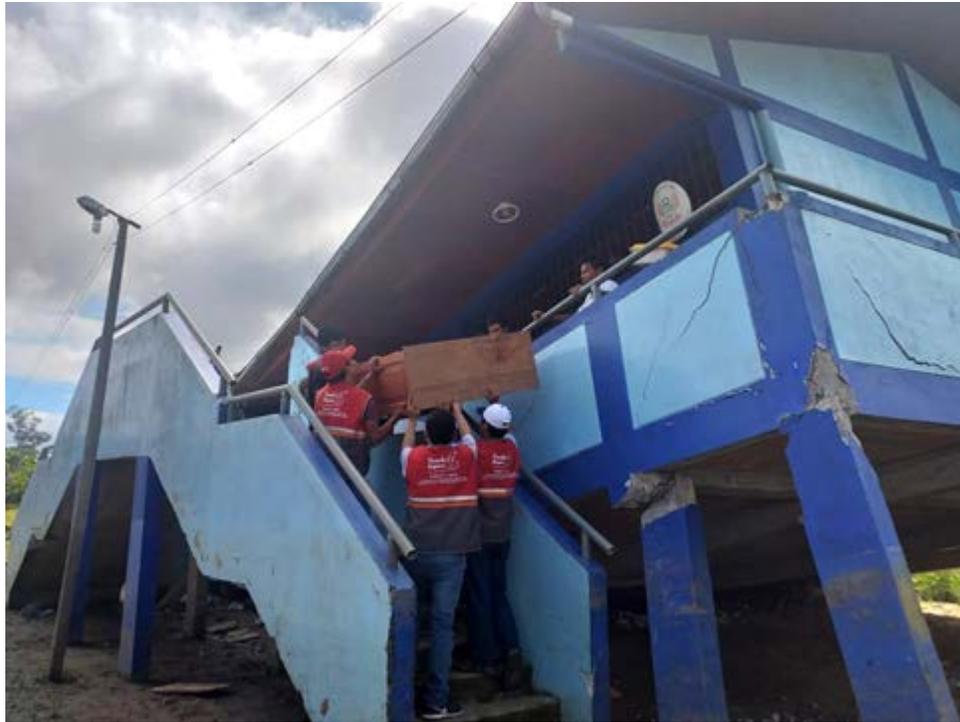
Figure 9.65. Structural damage in upper first story columns in a school building in La Esperanza, Perú (Source: Diario La Industria [6]).

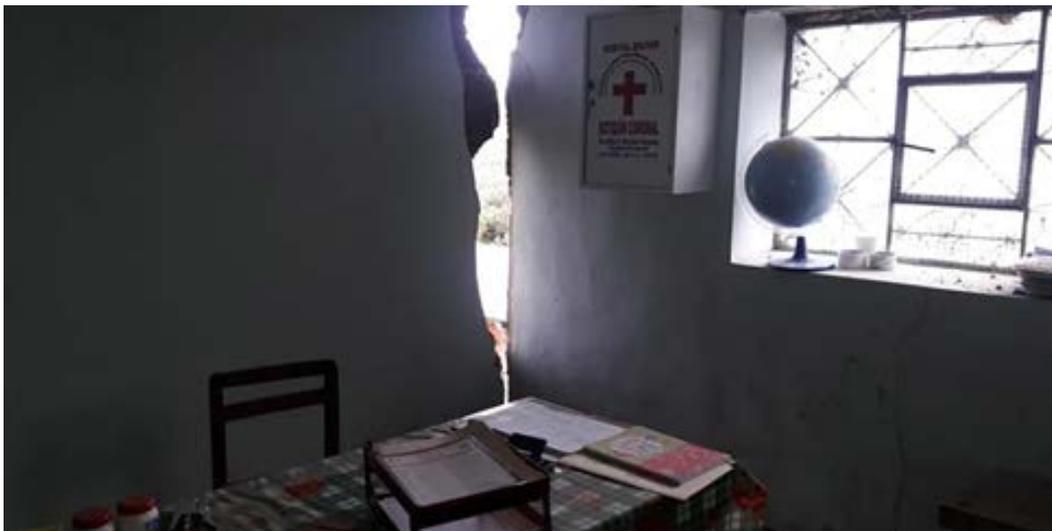
Figure 9.66. Masonry damage in junior high school building in Trujillo, Perú (Source: Diario La Industria [6]).

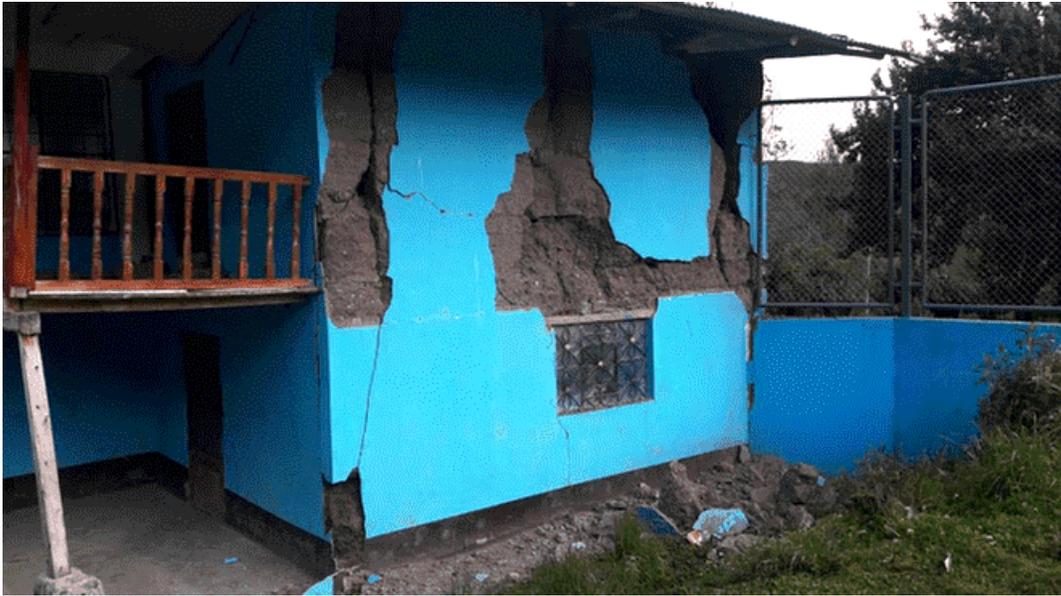
Figure 9.67. Damage in an two-story adobe school building in Cascapuy, Perú (Source: Diario La República [4]).

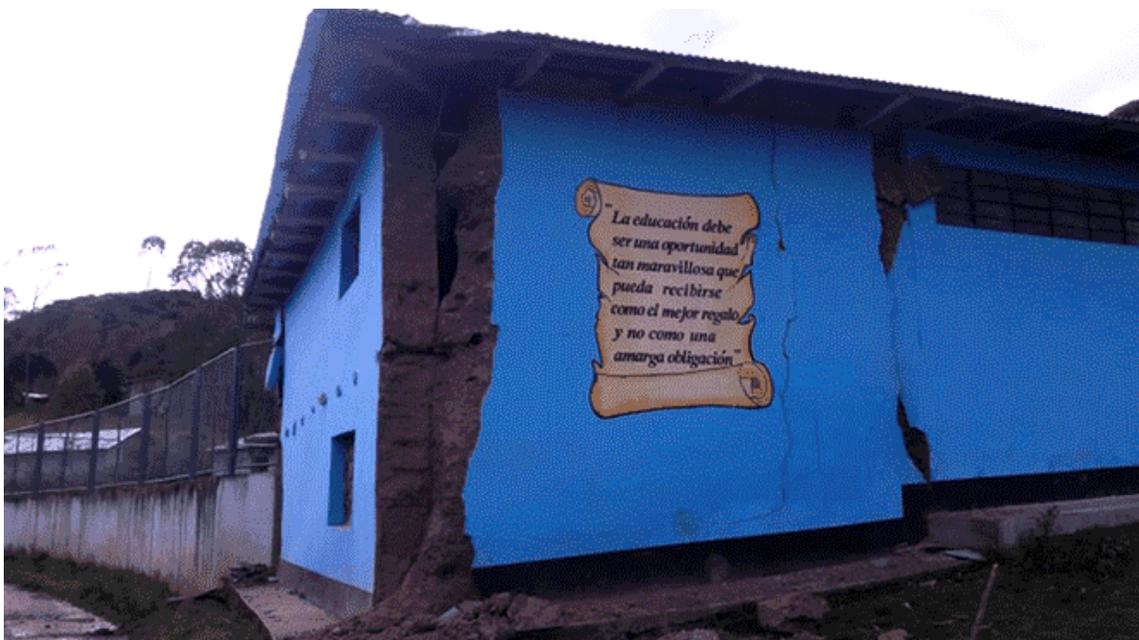
Figure 9.68. Damage in an adobe school building in Cascapuy, Perú (Source: Diario La República [4]).
