StEER
STRUCTURAL
EXTREME EVENTS
RECONNAISSANCE

LAGUNAS PERÚ MAY 26, 2019 EARTHQUAKE VIRTUAL ASSESSMENT STRUCTURAL TEAM (VAST) REPORT

Released: June 3, 2019 | **NHERI DesignSafe Project ID:** PRJ-2395

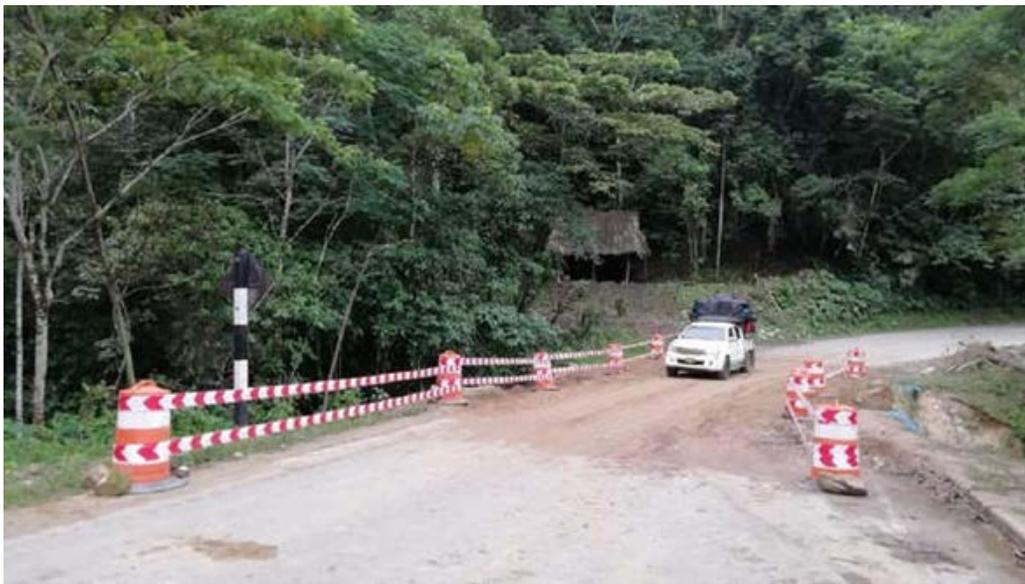
Figure 9.69. Bridge between Yurimaguas and Tarapoto (Puente Shimbillo) which suffered minor damaged after the earthquake [5].

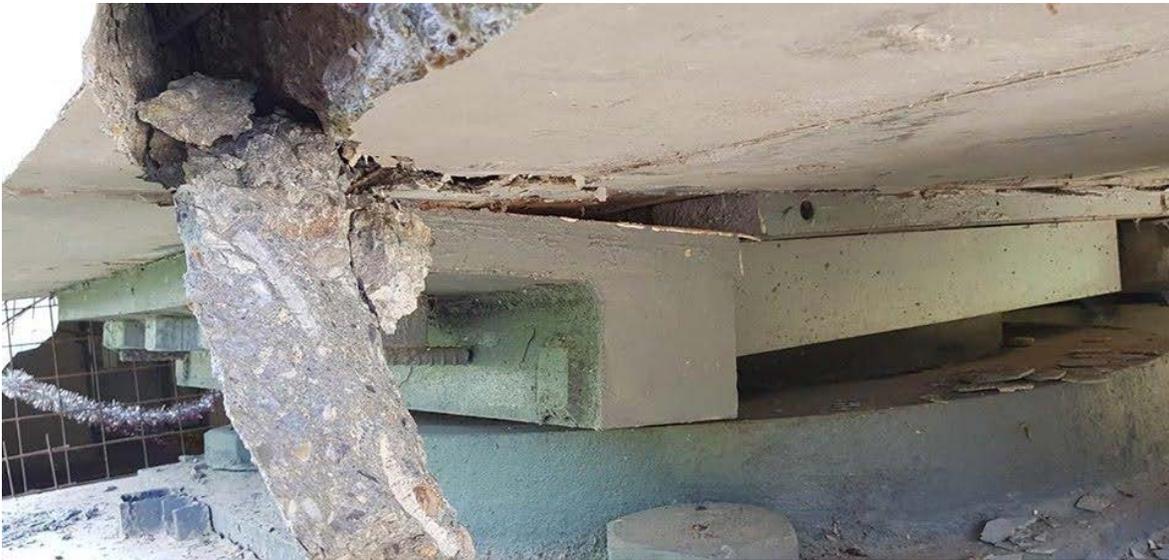
Figure 9.71. Concrete spalling near one of the supports of the bridge that crosses the Zamora river in Zamora Chinchipe province, Ecuador (Source: Bomberos El Pangui [7]).

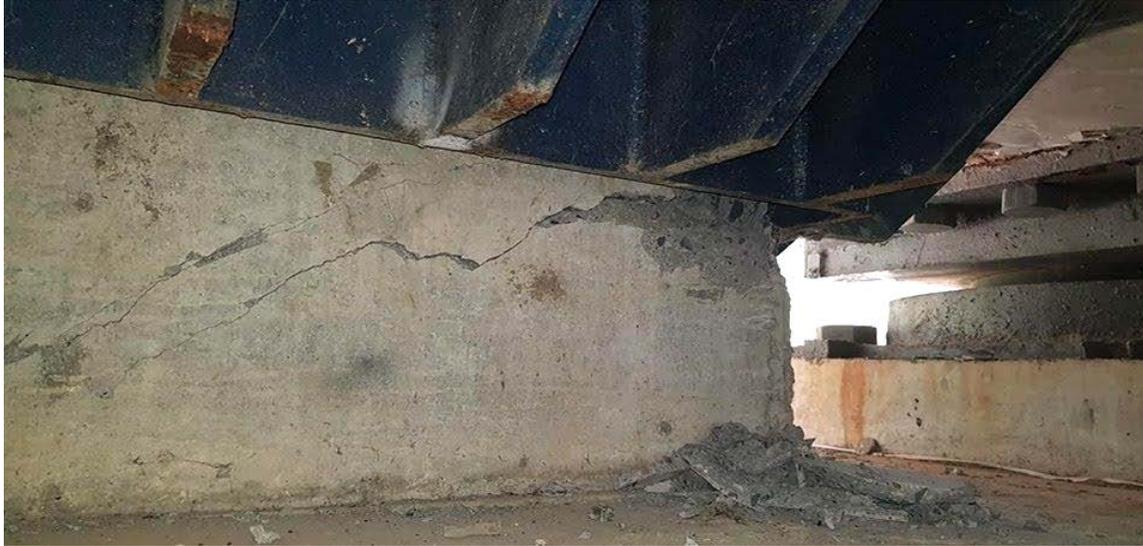
Figure 9.72. Shear cracking at the base of one of the supports of the bridge that crosses the Zamora river in Zamora Chinchipe province, Ecuador (Source: Bomberos El Pangui [7]).

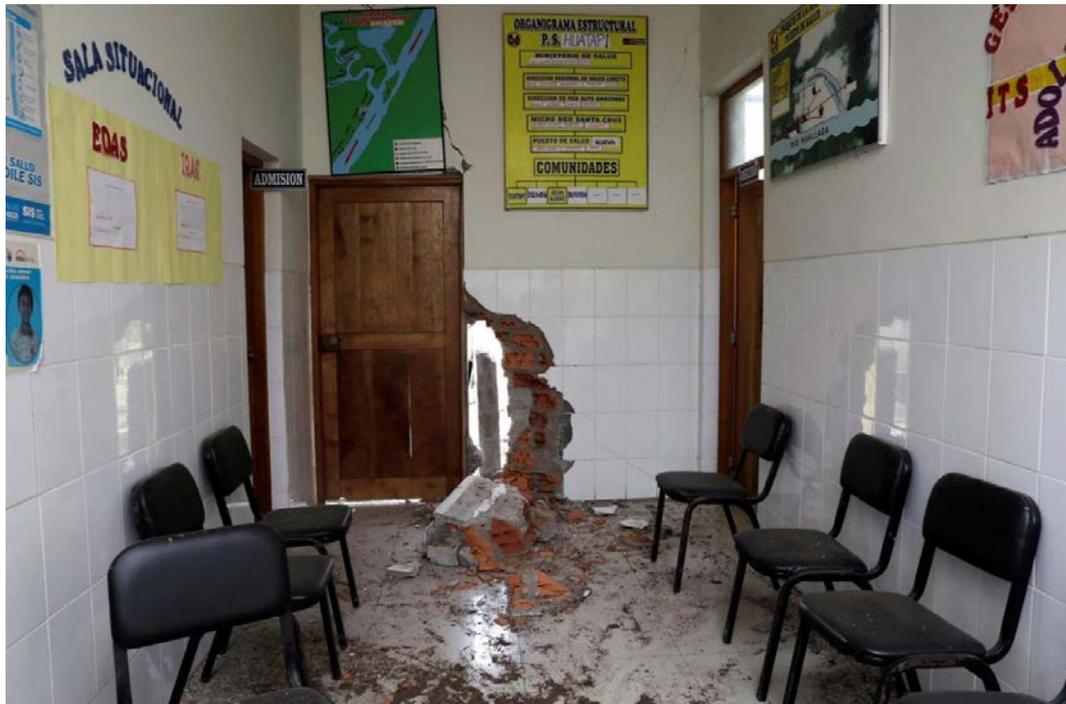
Figure 9.77. Severe damage in a masonry wall in a healthcare facility near Yurimaguas in the Amazon region of Peru (Jourdan et al. 2019).

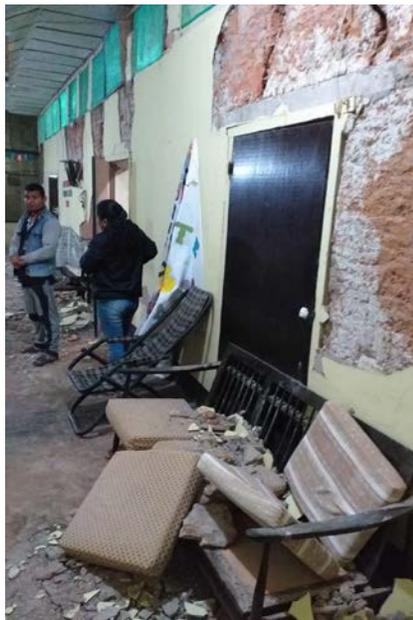
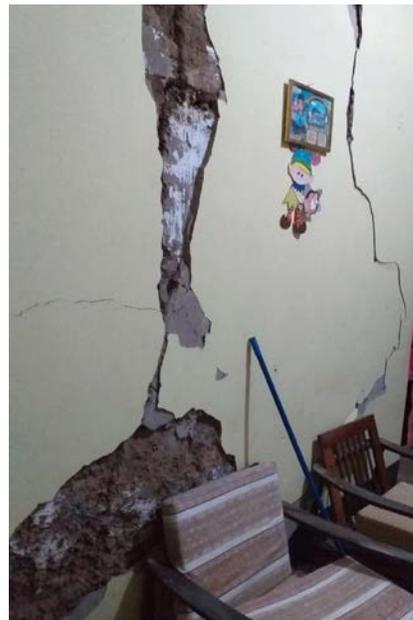
Figure 9.78. Plaster spalling and wall cracking in Lagunas, Loreto (Source: Rotafono [2]).

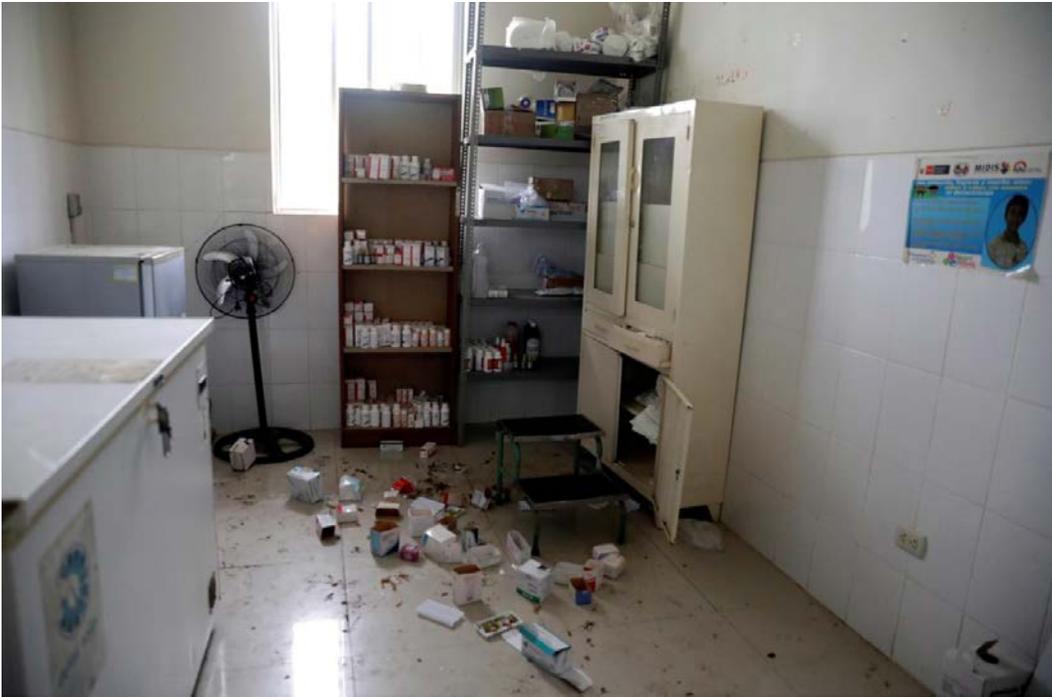
Figure 9.79. Medicine contents overturned by ground motions at Huatapi, from Capelo district, Requena province (Loreto) (Source: Rotafono [2]).
