StEER
STRUCTURAL
EXTREME EVENTS
RECONNAISSANCE

LAGUNAS PERÚ MAY 26, 2019 EARTHQUAKE VIRTUAL ASSESSMENT STRUCTURAL TEAM (VAST) REPORT

Released: June 3, 2019 | **NHERI DesignSafe Project ID:** PRJ-2395

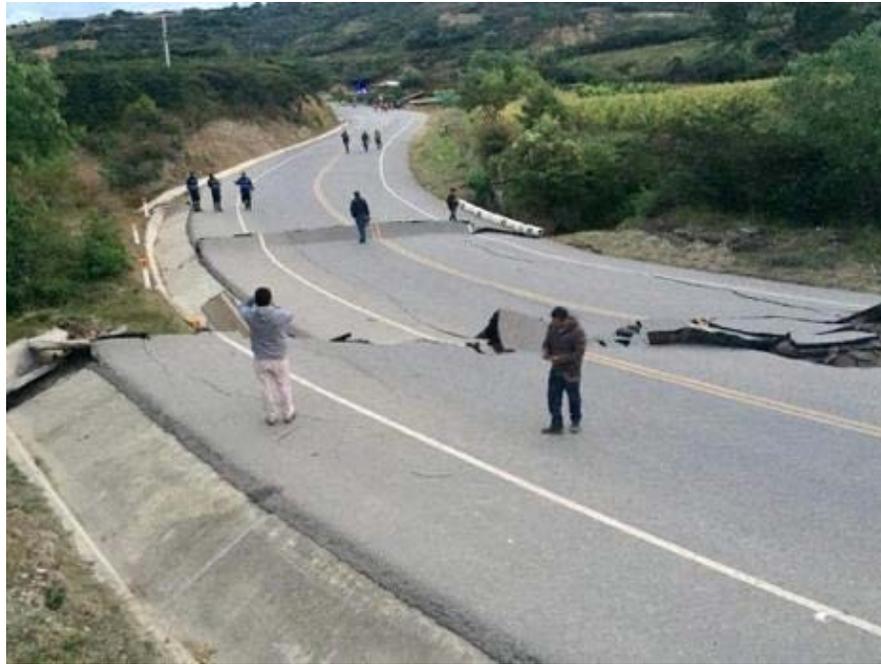
Figure 9.2. Cajabamba-Cajamarca road, close to Huañiamba (COEN, 2019).

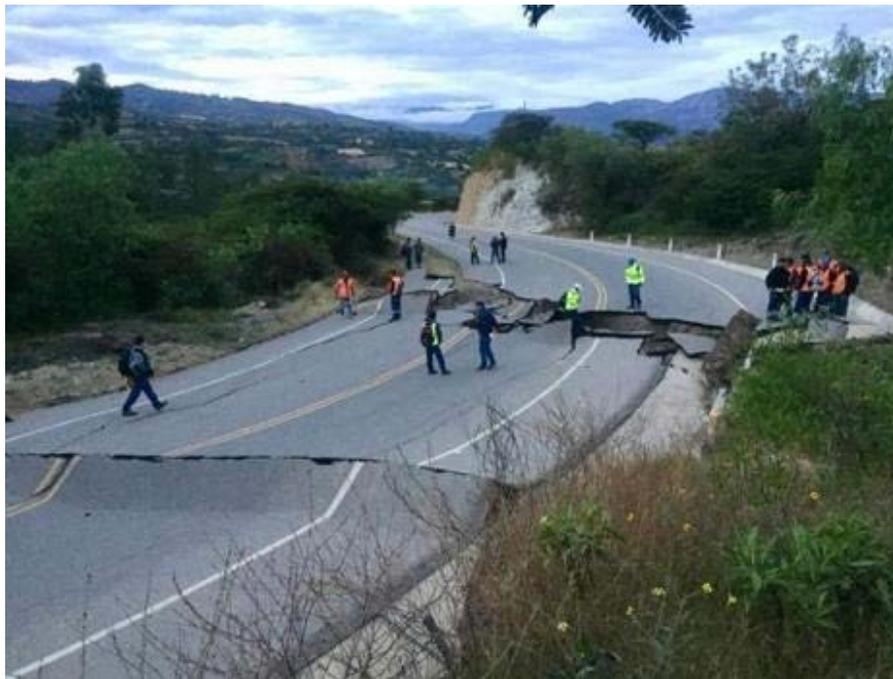
Figure 9.3. Cajabamba-Cajamarca road, close to Huañiamba (COEN, 2019).

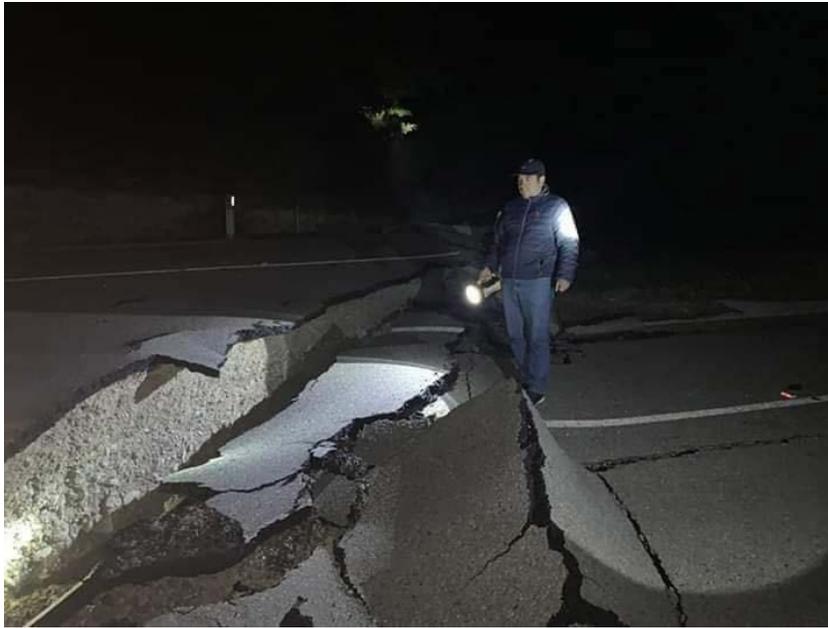
Figure 9.4. Cajabamba-Cajamarca, close to Huañiamba (COEN, 2019).

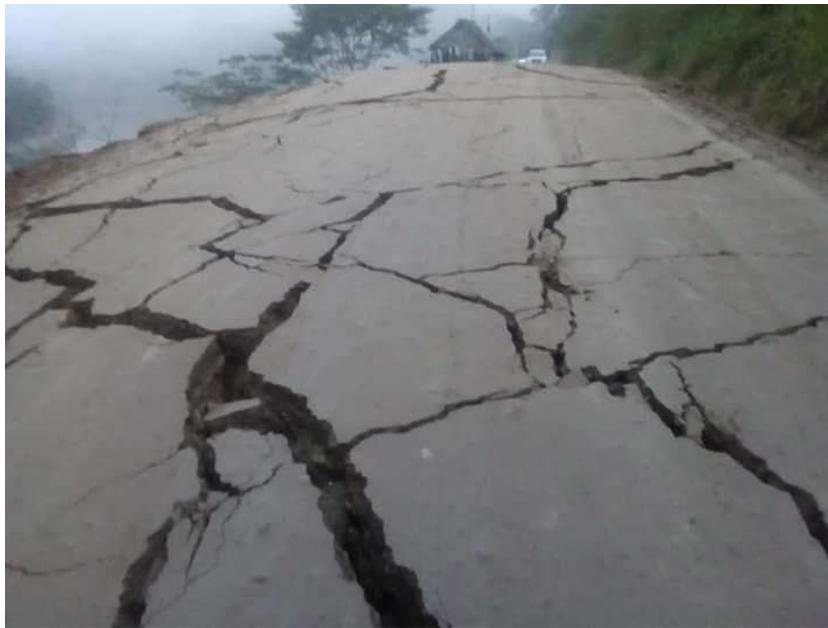
Figure 9.5. Road connecting Cajamarca, Huanuco and La Libertad (Source: Cuarto Poder, TV News).

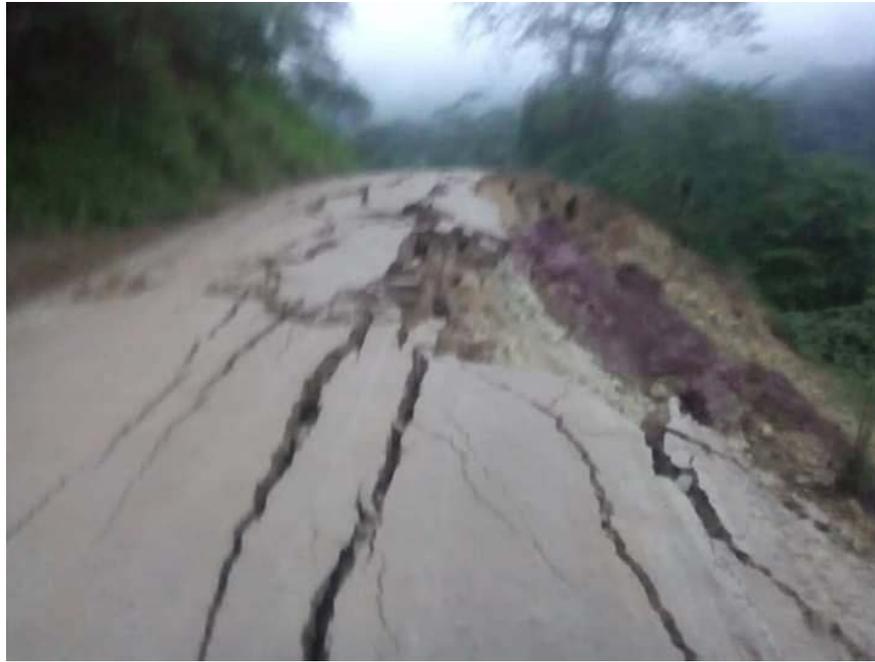
Figure 9.6. Road connecting Cajamarca, Huanuco and La Libertad (Source: Cuarto Poder, TV News).

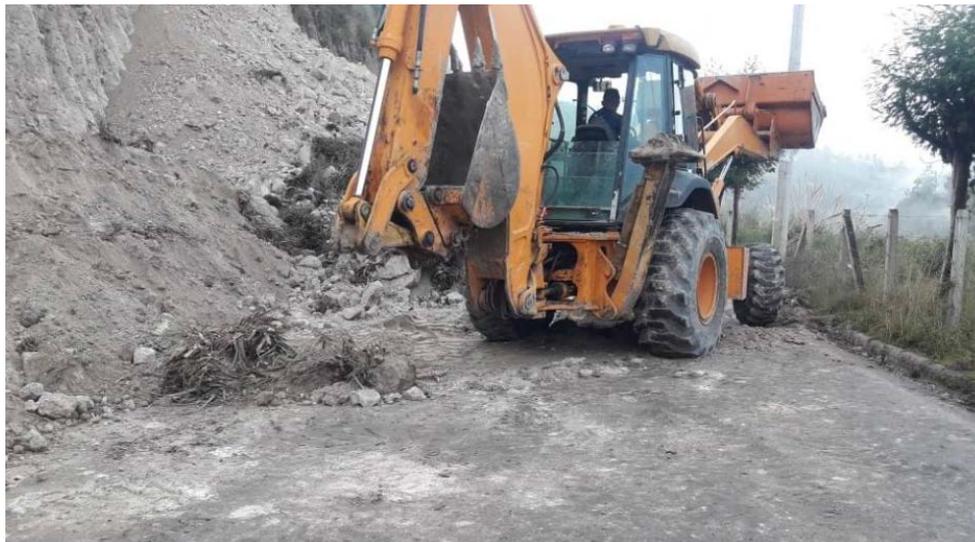
Figure 9.7. Landslide at the Gualaceo-Sigsig highway at the Province of Azuay (Source: Diario El Universo [1]).

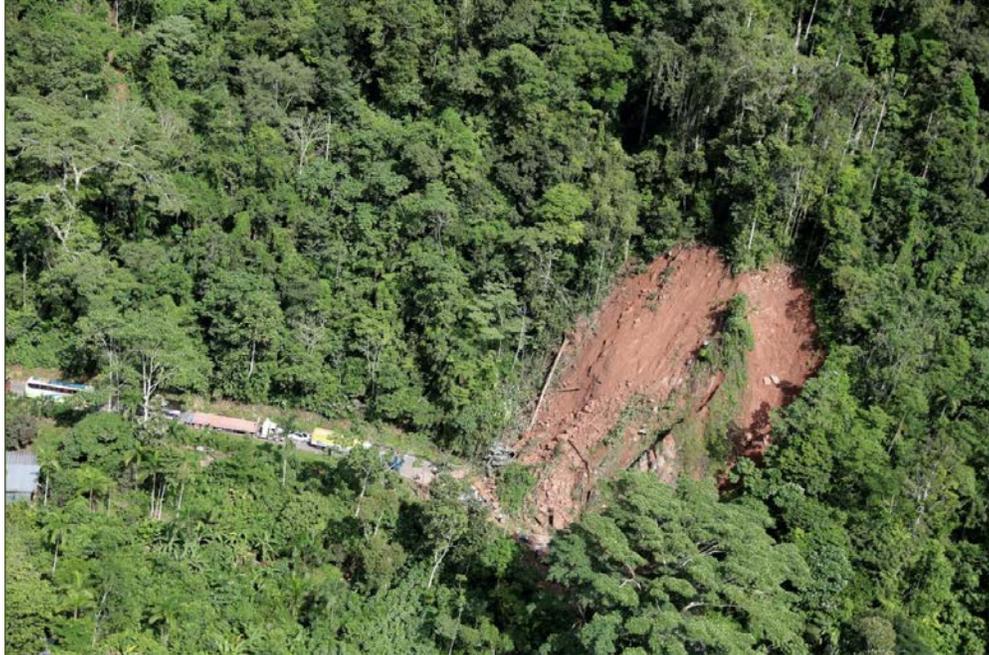
Figure 9.8. An aerial view of a landslide near Yurimaguas in the Amazon region of Peru (Jourdan et al. 2019).

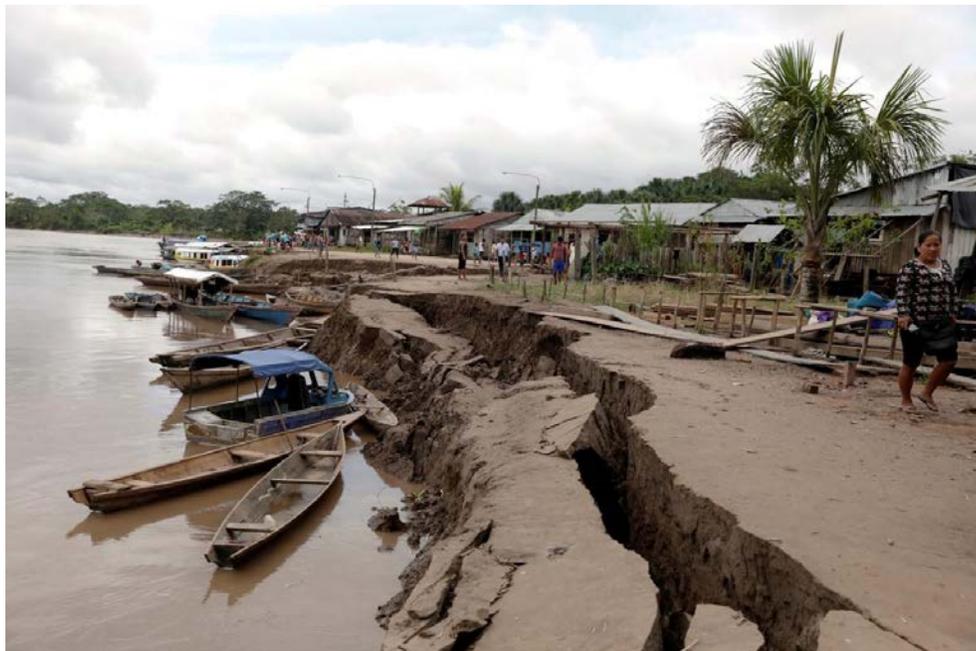
Figure 9.9. Lateral spreading along the Huallaga river at the Santa Gema near Yurimaguas in the Amazon region of Peru (Jourdan et al. 2019).

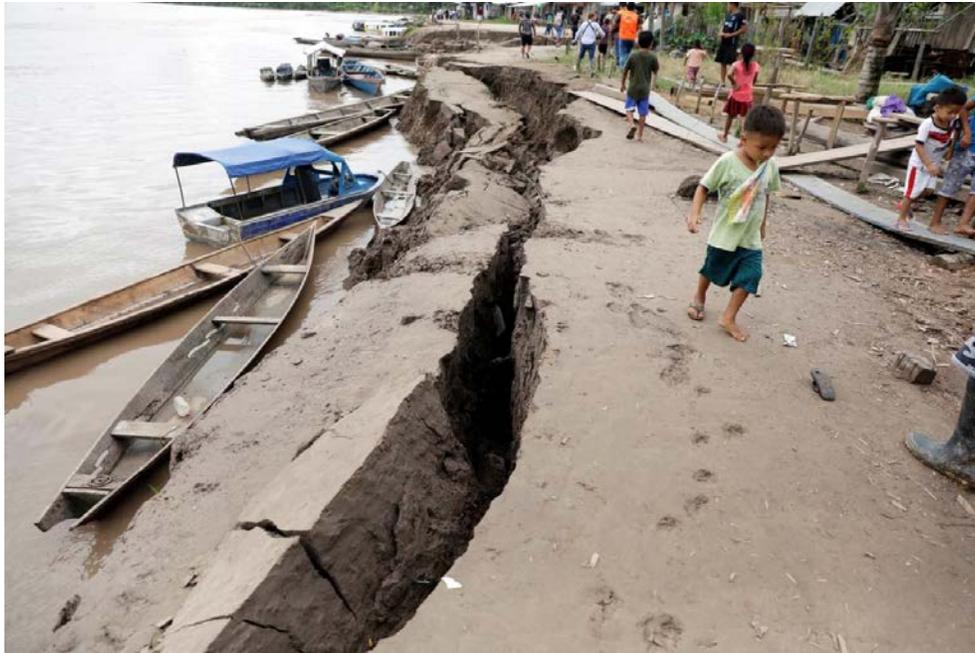
Figure 9.10. Lateral spreading along the Huallaga river at the Santa Gema near Yurimaguas in the Amazon region of Peru (Jourdan et al. 2019).

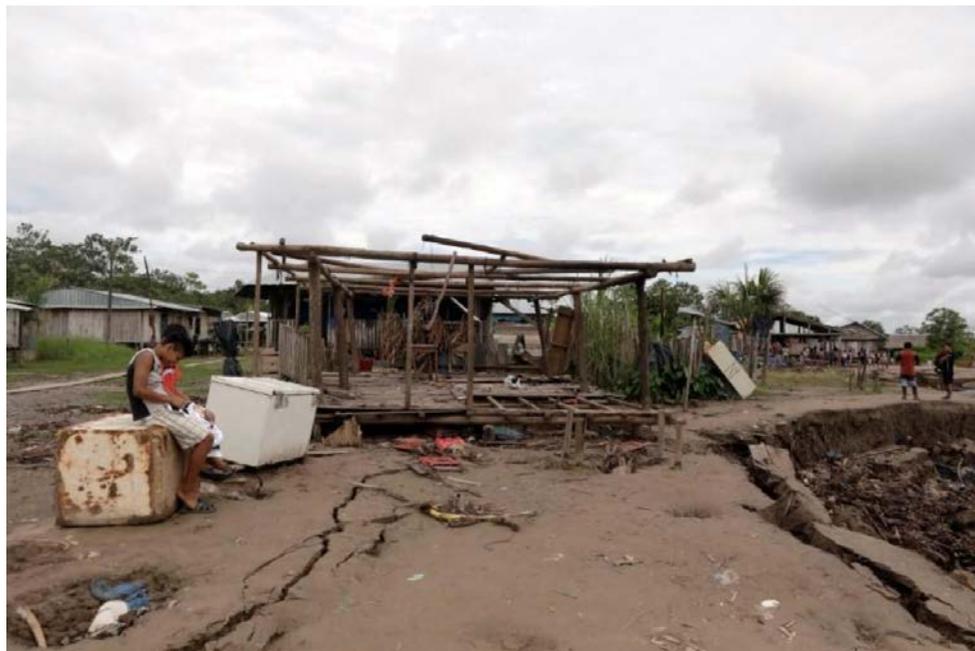
Figure 9.11. Lateral spreading along the Huallaga river at the Santa Gema near Yurimaguas in the Amazon region of Peru, (Jourdan et al. 2019).

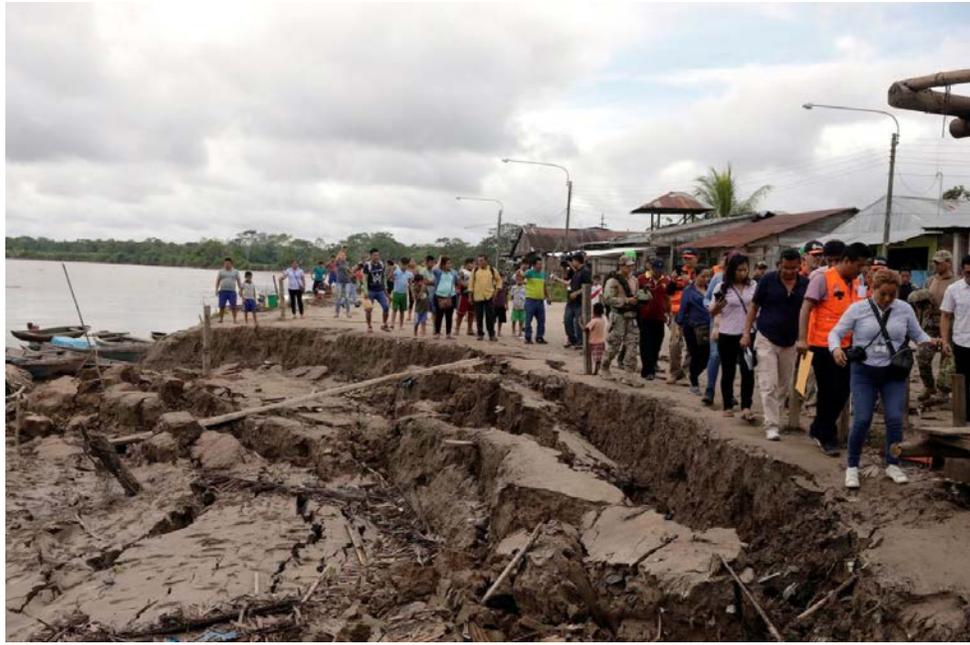
Figure 9.12. Lateral spreading along the Huallaga river at the Santa Gema near Yurimaguas in the Amazon region of Peru, (Jourdan et al. 2019).

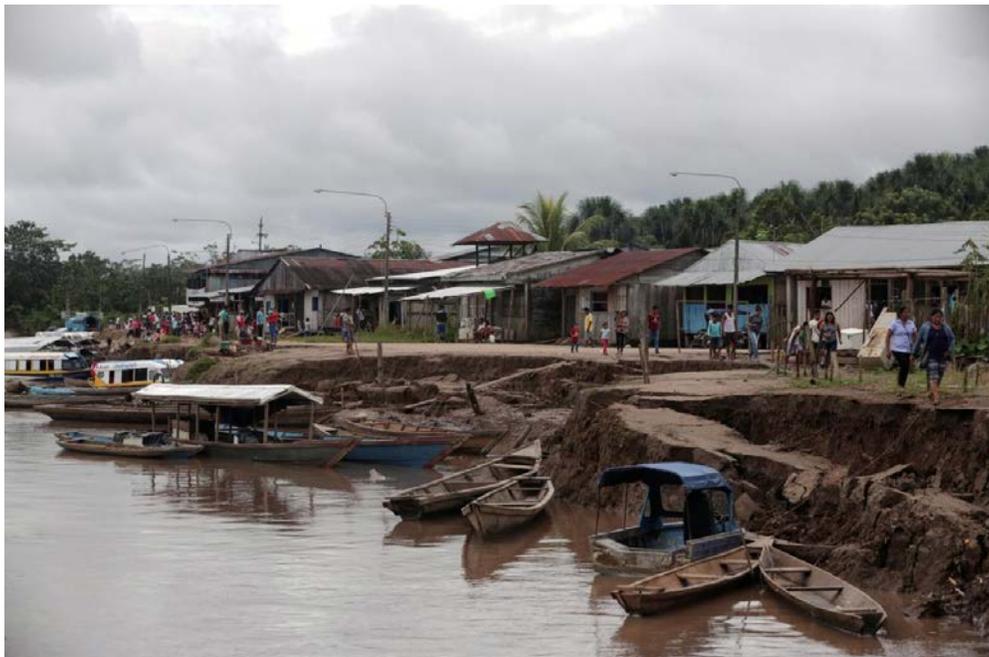
Figure 9.13. Lateral spreading along the Huallaga river at the Santa Gema near Yurimaguas in the Amazon region of Peru, (Jourdan et al. 2019).

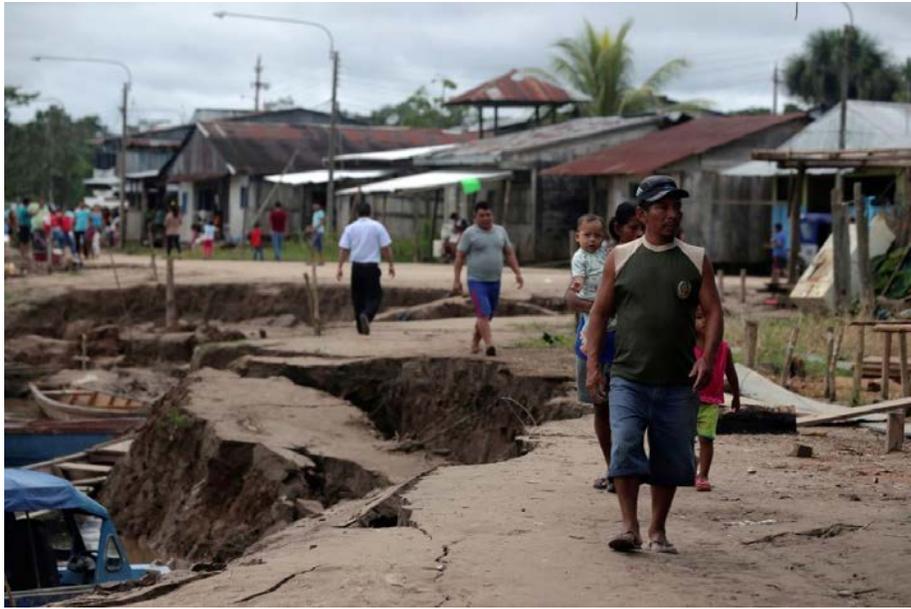
Figure 9.14. Lateral spreading along the Huallaga river at the Santa Gema near Yurimaguas in the Amazon region of Peru, (Jourdan et al. 2019).

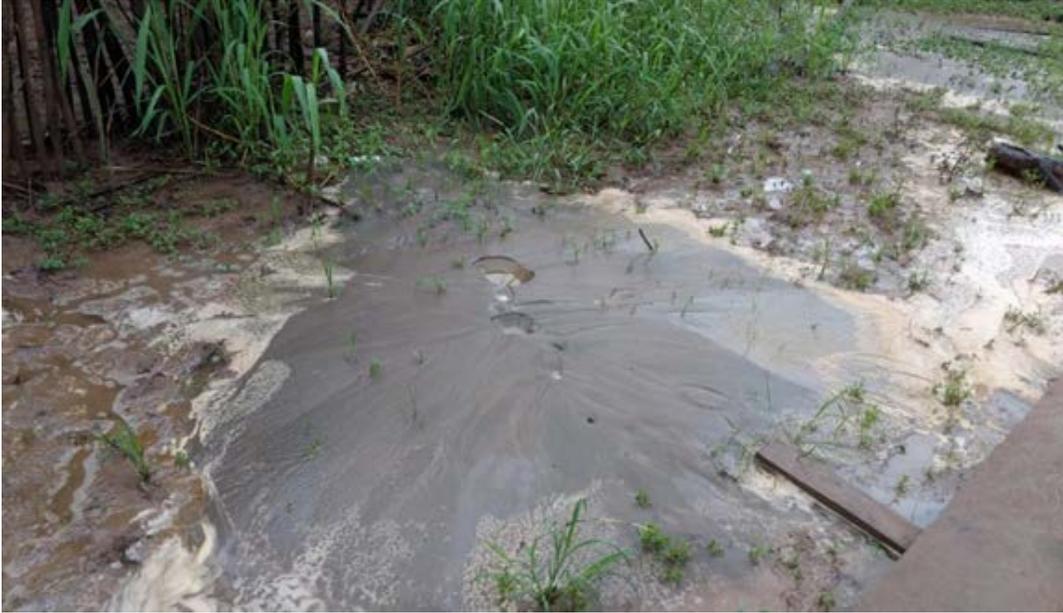
Figure 9.18. Liquefaction ejecta in district of Lagunas in Alto Amazonas, 145 km away from epicenter Loreto Region, (Source: Perú 21).

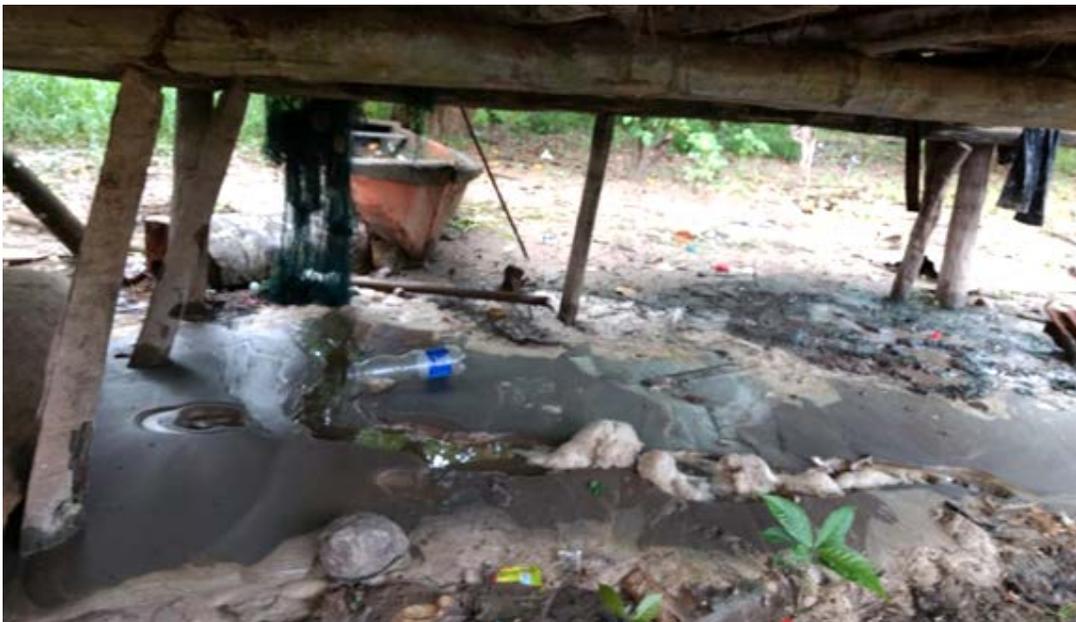
Figure 9.19. Liquefaction ejecta under a house built on wooden piles in district of Lagunas in Alto Amazonas, 145 km away from epicenter, Loreto Region. (Source: Perú 21).

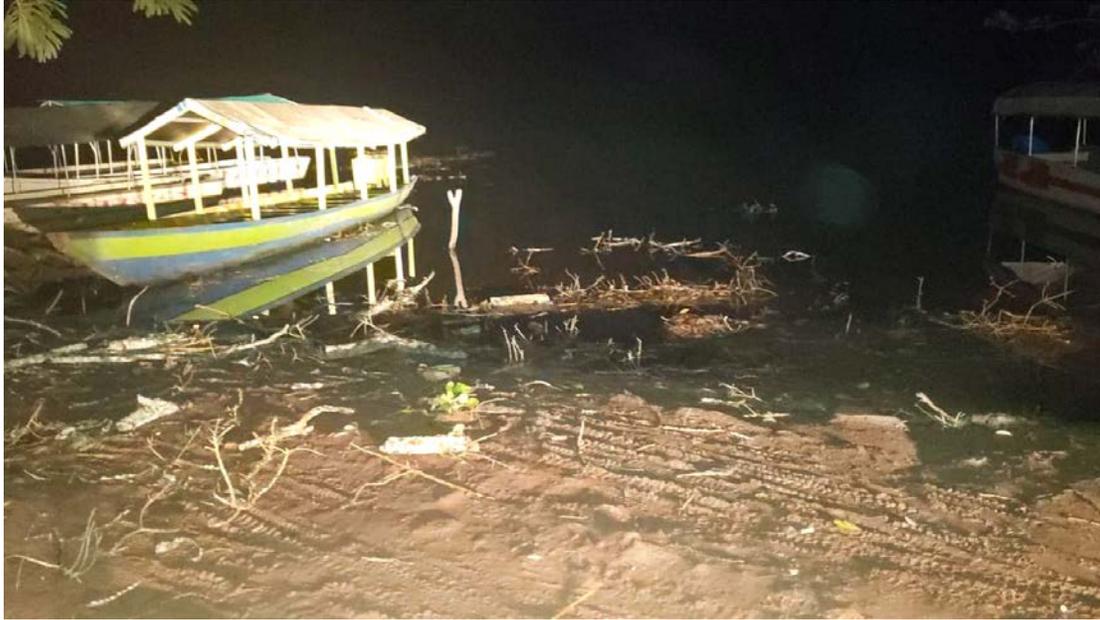
Figure 9.20. Liquefaction at the Sauce district and Caserio 2 de Mayo in San Martin. (Source: Rotafono [2]).

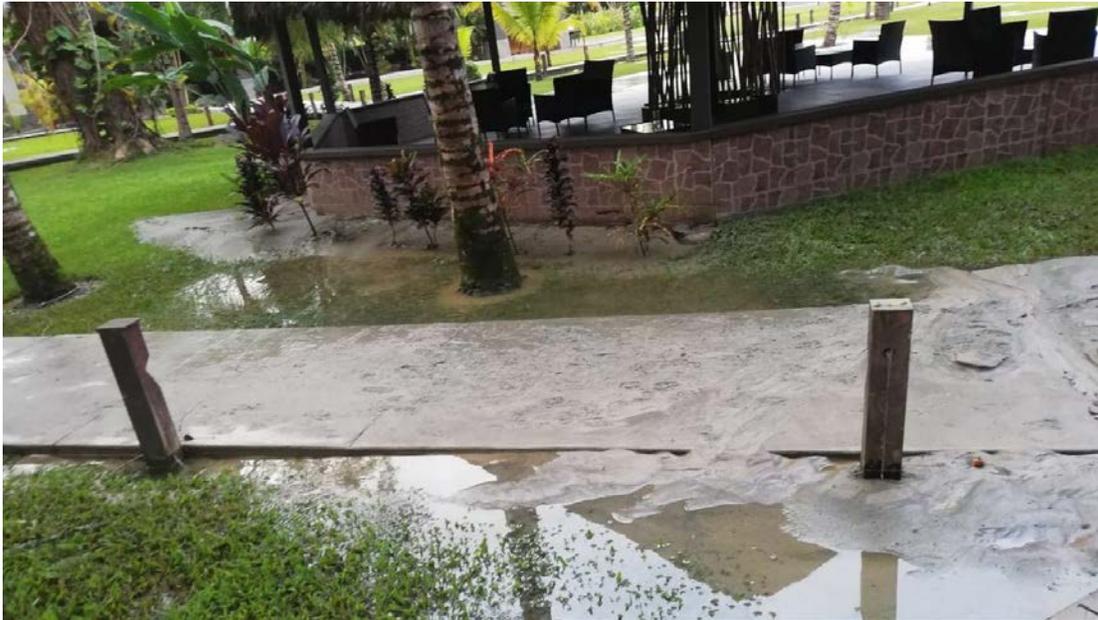
Figure 9.24. Liquefaction ejecta in El Sauce Resort, Tarapoto (Source: Rotafono [2]).

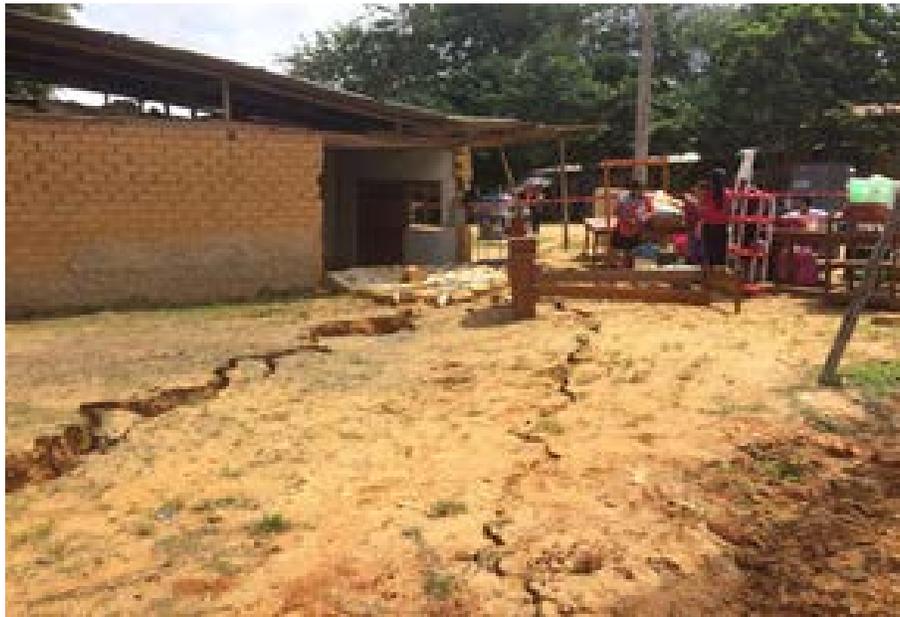
Figure 9.29. Seismically-induced ground damage at El Sauce District (Source: Ministerio de Vivienda del Perú - Photo by Miguel Estrada).

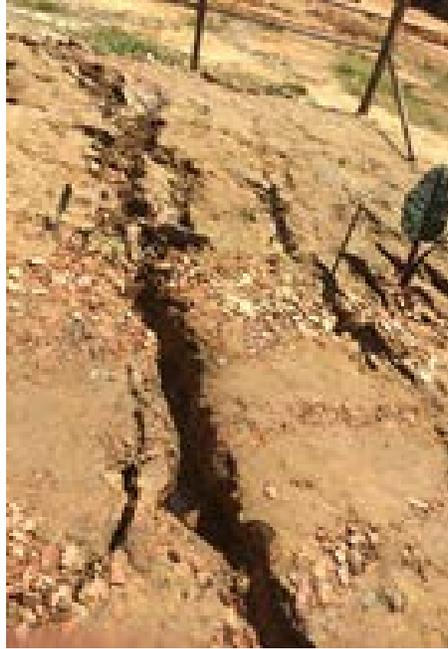
Figure 9.32. Seismically-induced ground damage at El Sauce District (Source: Ministerio de Vivienda del Perú - Photo by Miguel Estrada).

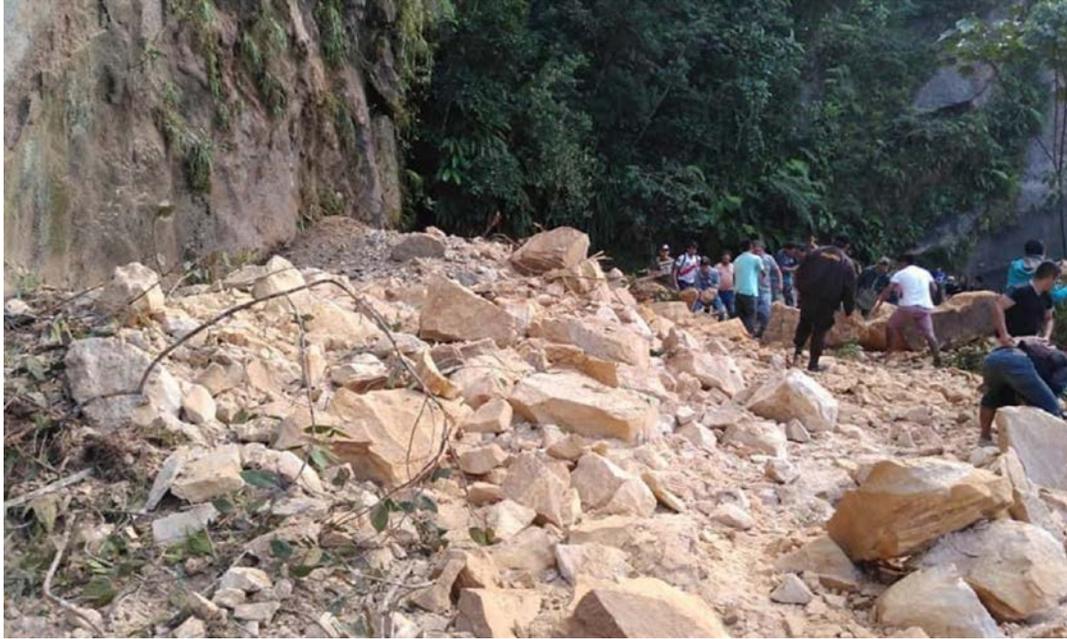
Figure 9.34. Yurimaguas-Tarapoto road, hill landslides (Source: @govanniacate via Twitter).

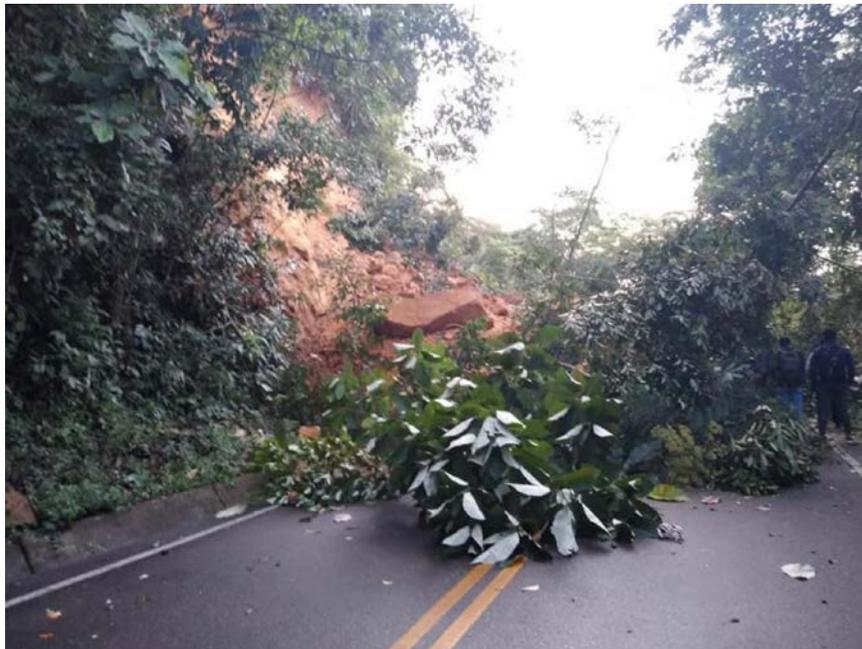
Figure 9.35. Yurimaguas-Tarapoto road, hill landslides (Source: @govanniacate via Twitter).

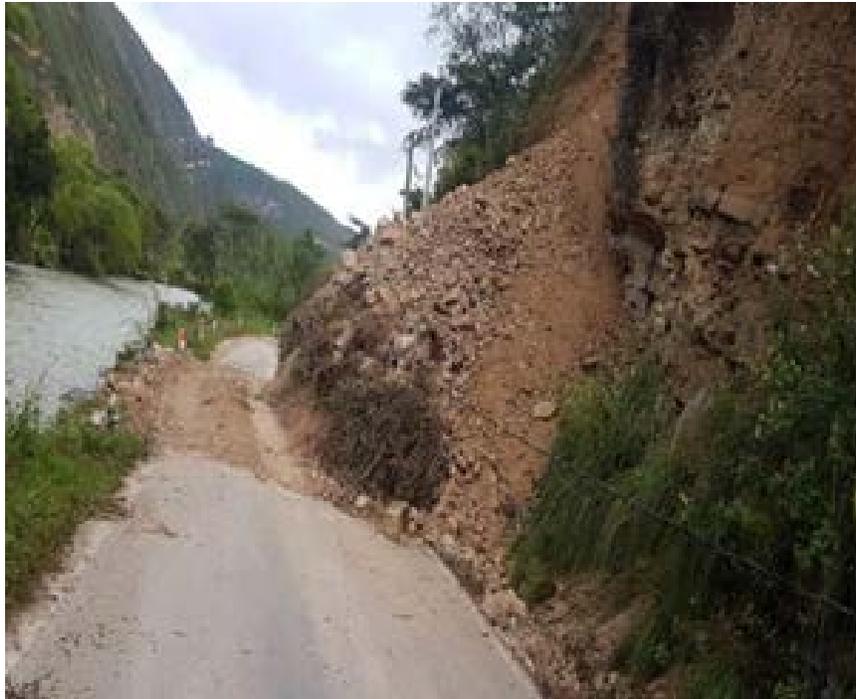
Figure 9.36. Landslides at the Leymebamba-Chachapoyas road, Ubillon sector, km 272+00, Amazonas (COEN, 2019).

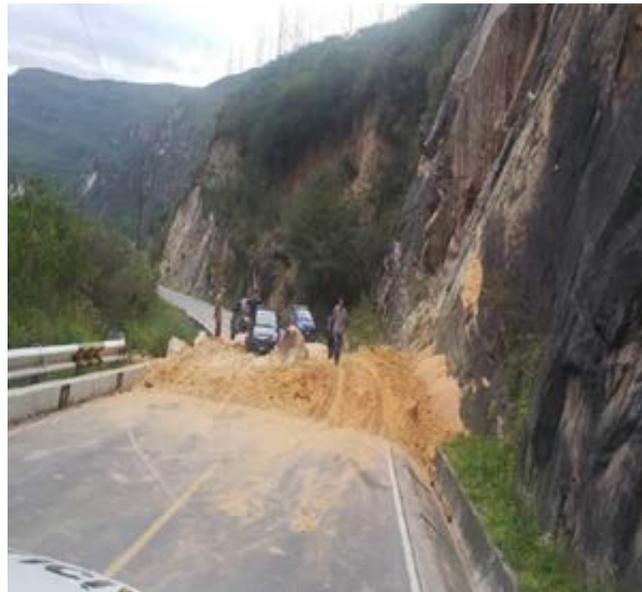
Figure 9.37. Landslides at the Leymebamba-Chachapoyas road, Ubillon sector, km 272+00, Amazonas (COEN, 2019).

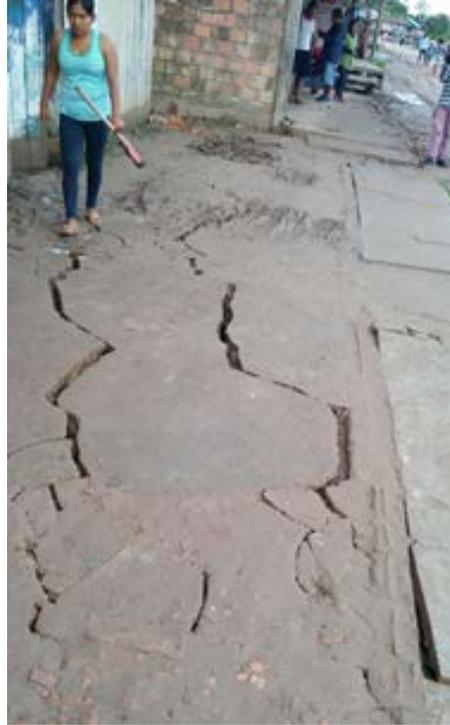
Figure 9.38. Huallaga pier at Lagunas with apparent lateral spreading effects (Source: @govanniacate via Twitter).

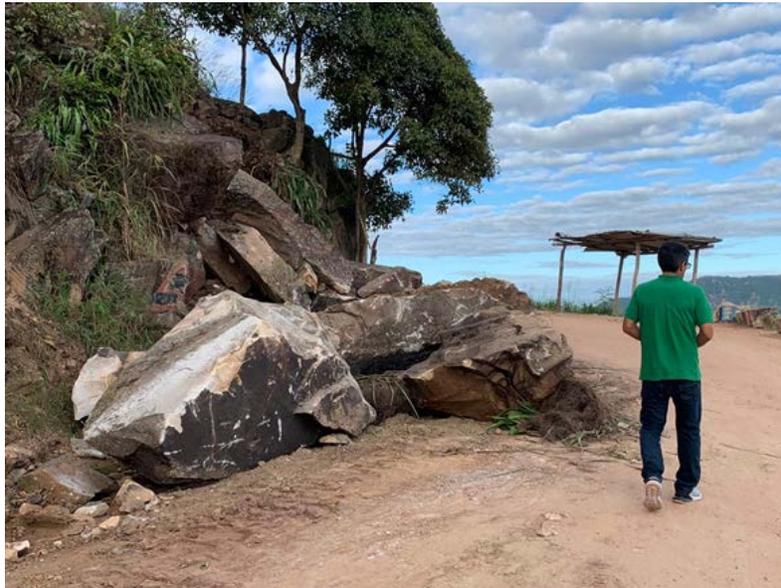
Figure 9.39. Rockfall at 2 de Mayo village (located at 1.5 hours from Tarapoto, Sauce district) (Reategui and Mora, 2019).

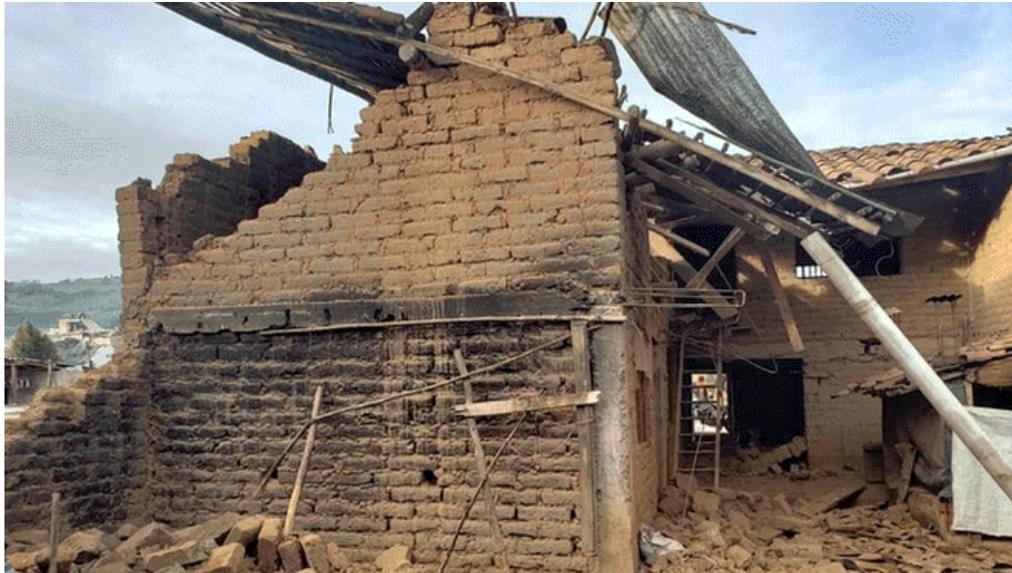
Consistent with post-earthquake field observations from past Peruvian earthquakes, and other earthquake-prone regions in developing countries, housing dwellings built with adobe suffered severe damage (Figure 9.46). Typical failure modes observed in the dwellings included vertical cracking at the corners of the house, which typically then leads to out-of-plane failures of the adobe walls. Traditionally, adobe walls do not have any type of vertical and horizontal reinforcement and have extremely low shear and lateral deformation capacity. Another structural deficiency is that roofs usually support heavy clay tiles that are prone to collapse as shown in Figures 9.47 and 9.48. Some housing dwellings in the affected region were built using hollow clay brick masonry walls, which also suffered structural damage. Some of this damage was produced by diagonal tension cracking which in some cases lead to out-of-plane failure of the walls as shown in Figure 9.49. In some cases collapse of corner adobe was observed at dwellings and buildings as shown in Figure 50 and 51. Figure 9.52 shows debris caused by the collapse of a parapet in a corner two-story adobe building in Yurimaguas City.

Figure 9.47. Collapse of old-housing dwelling built of adobe brick units in Huamachuco (Source: Diario La República [4]).

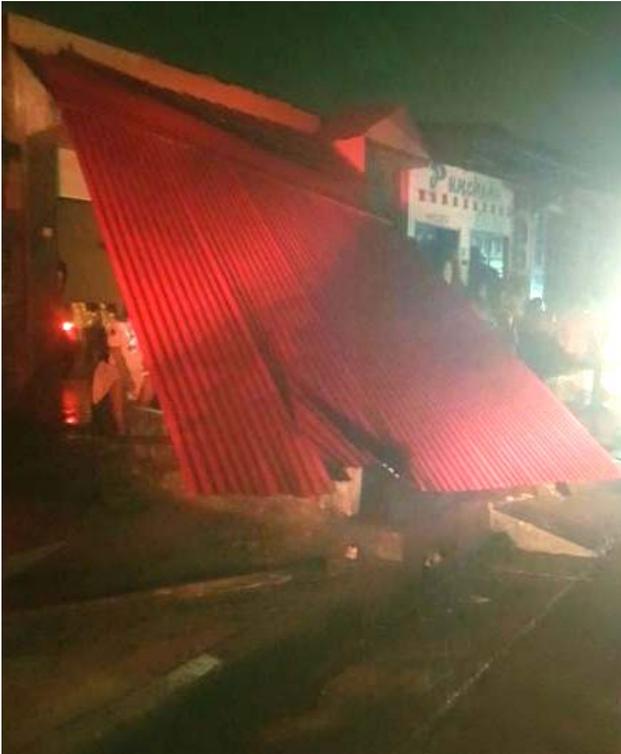
Figure 9.48. Collapsed roof structure in, Yurimaguas City, Loreto Region (Holguin, 2019 Source: Peruvian Fire-Department [7]).

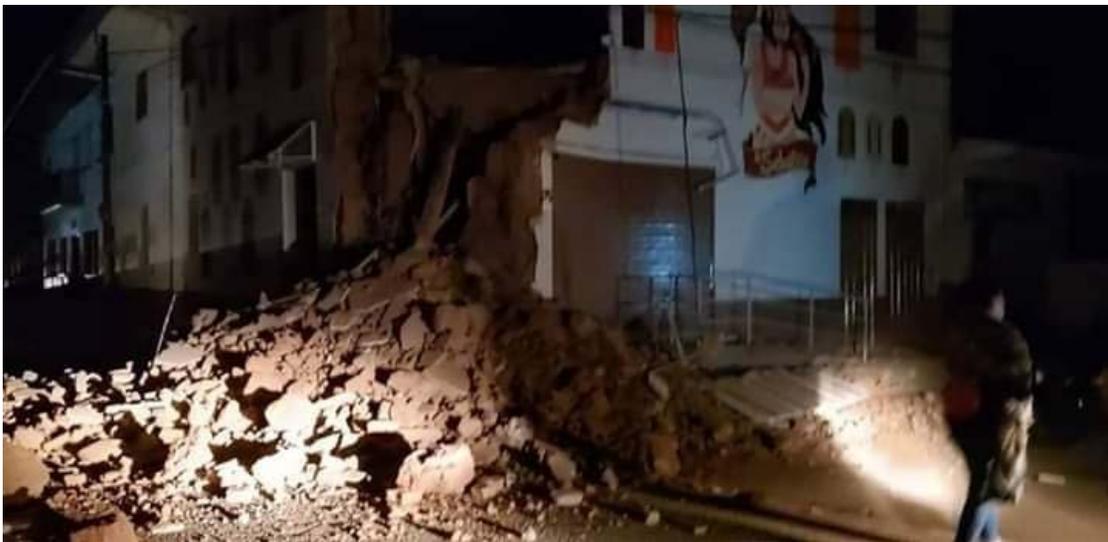
Figure 9.52. Partial collapse of the same two-story adobe building in Yurimaguas City (COEN, 2019).

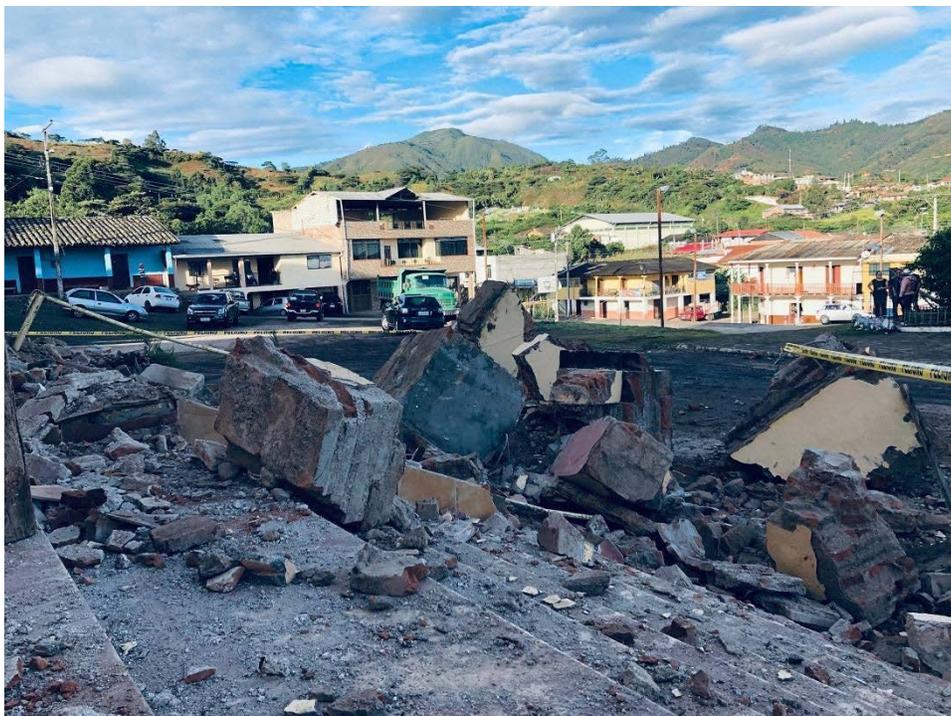
The earthquake resulted in the collapse of 5 churches and produced damage in 15 other churches. Figures 9.55 and 9.56 show part of a heritage church bell tower that collapsed in the town of Nambacola in the province of Loja. Nambacola is located at 56 km to the southwest of Loja city, the capital of the province of Loja. Loja city is located about 490 km from the epicenter. The church presents some cracking, and the bells that dated from 1901 were destroyed when the bell tower of the church collapsed. This structure was registered as part of the Cultural Heritage since 2015.

Figure 9.56. A heritage church bell tower that collapsed in the town of Loja, Ecuador (Cueva, 2019).

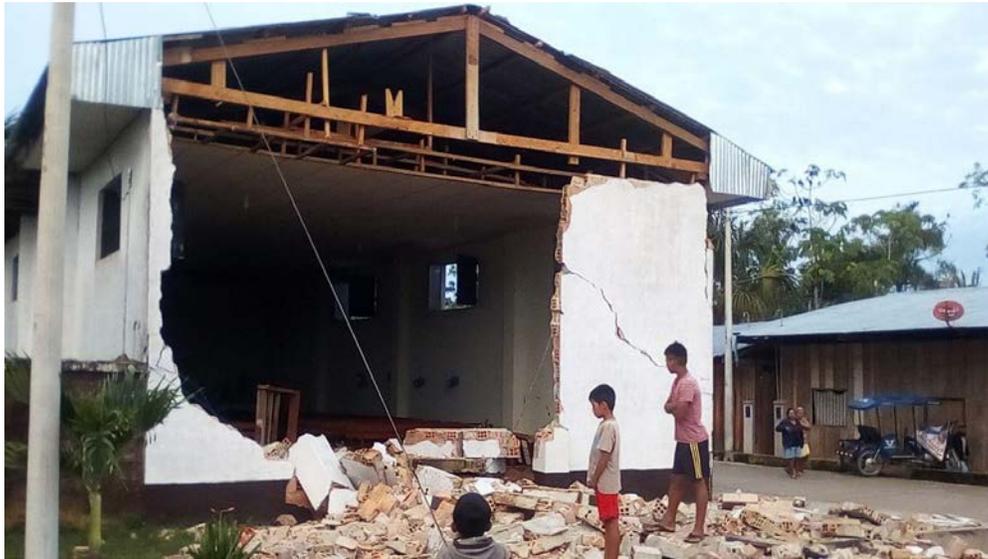
Figure 9.57. Out-of-plane collapse of a masonry wall at a church in Santa Cruz, Alto Amazonas province, in the Loreto region (Source: Rotafono [2]).

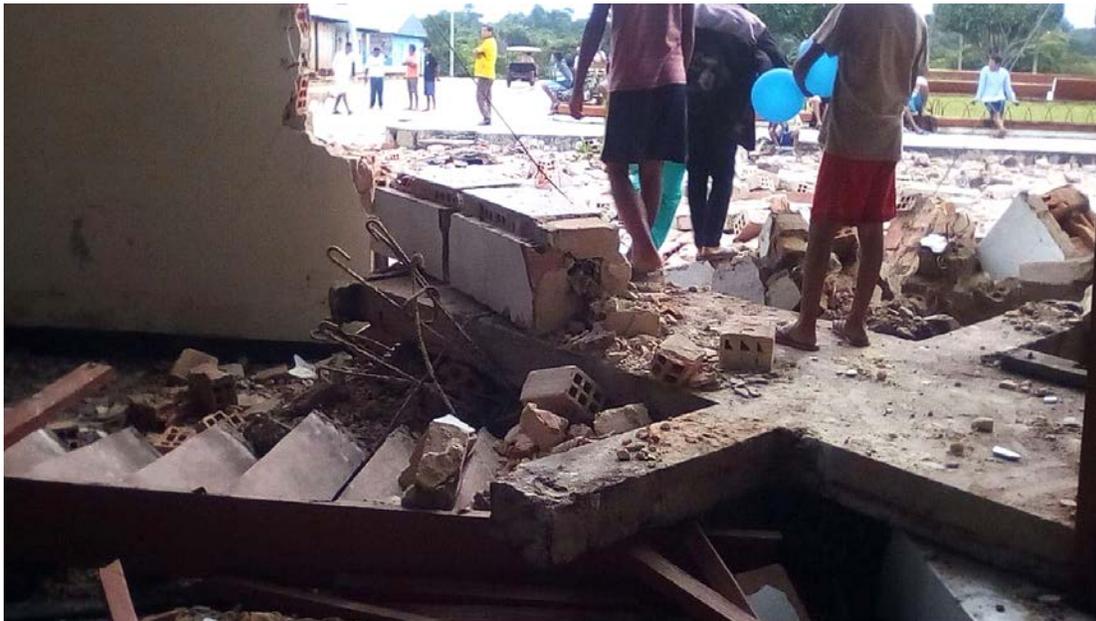
Figure 9.58. Out-of-plane collapse of a masonry wall at a church in Santa Cruz, Alto Amazonas province, in the Loreto region (Source: Rotafono [2]).

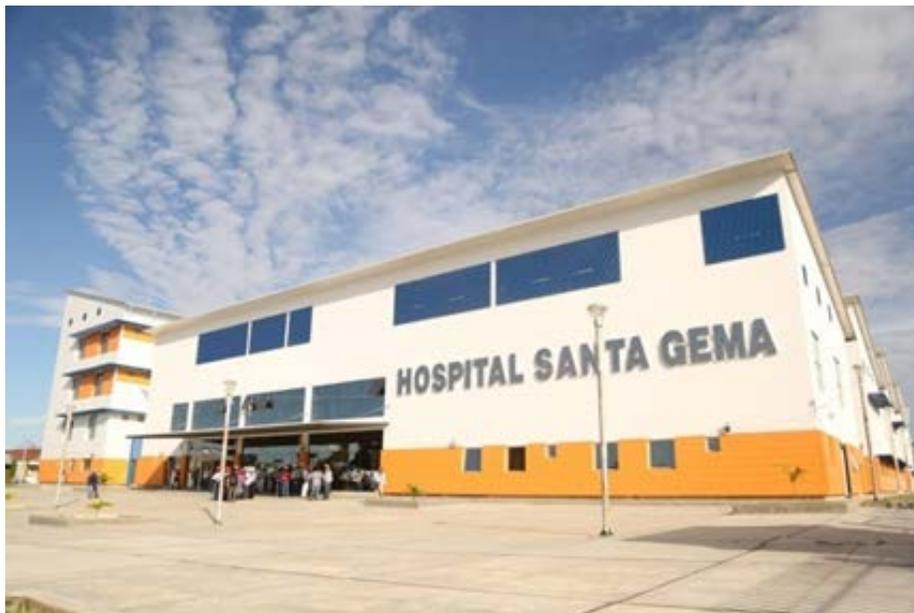
Figures 9.60 to 9.62 show the severe damage of a healthcare facility in Huatapi, near Yurimaguas. The new Santa Gemma hospital in Yurimaguas is a base-isolated structure (Figure 9.63) that had a very good performance during the earthquake except for small cracking that was observed near the Surgery department. The isolation bearing in the hospital are lead-core rubber bearing isolators which are shown in Figure 9.64.

Figure 9.63. Base-isolated hospital in Yurimaguas region (Courtesy of CIV Ingeniería Antisísmica).

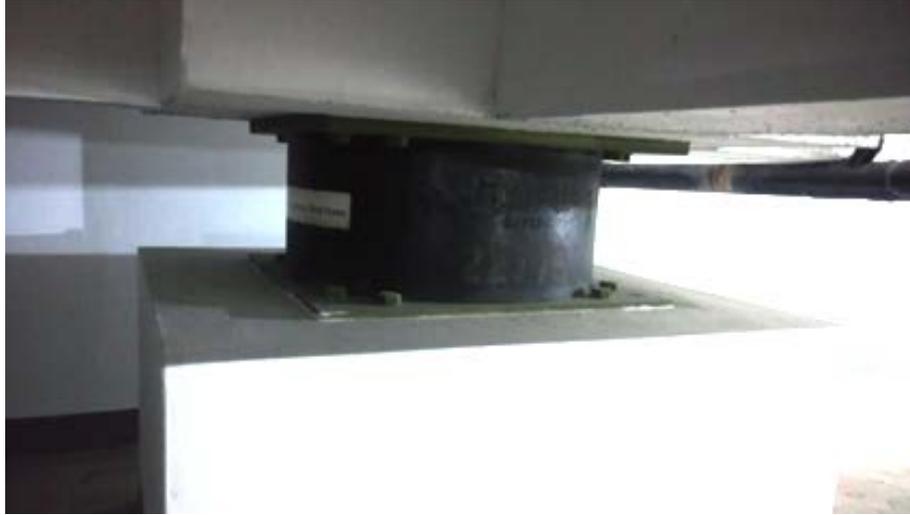
Figure 9.64. Lead-core rubber bearing base-isolator at hospital in Yurimaguas region (Courtesy of CVI Ingeniería Antisísmica).

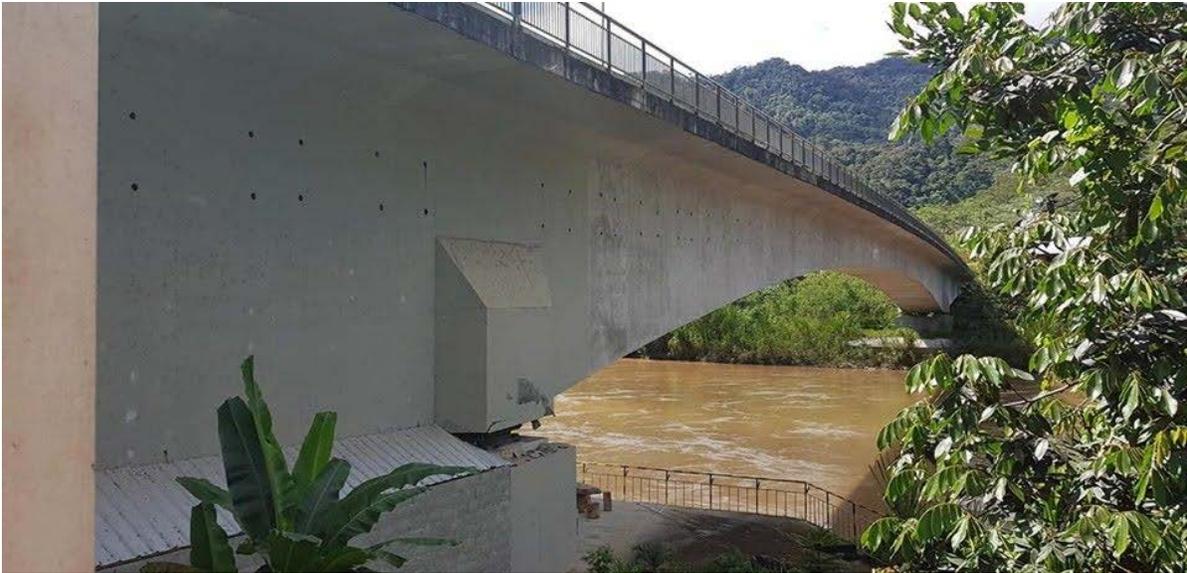
It was reported that the bridge between Yurimaguas and Tarapoto (Puente Shimbillo) suffered cracking in the asphalt surface (Figure 9.69). In the City of El Pangui, Zamora Chinchipe province in Ecuador, it was reported that the bridge that crosses the Zamora river suffered severe cracking at the bents (Figures 9.70 to 9.72). A vertical displacement of about 7 cm was measured after inspection of the bridge. A recently built international small container port in Yurimaguas on the Huallaga River, did not suffer any damage and it remained fully operational after the earthquake Figure 9.73. The port structure consists of precast reinforced concrete (RC) beams supported by steel tube piles as shown in Figures 9.74 and 9.75. The superstructure consists of RC precast beams supporting precast slabs, as shown in Figure 9.76, prior to the pouring of the concrete topping. The precast slabs have welded steel trusses so they are self-supported, including the “in situ” concrete weight and construction loads.

Figure 9.70. Overall view of the bridge that crosses the Zamora river in Zamora Chinchipe province, Ecuador (Source: Bomberos El Pangui [7]).

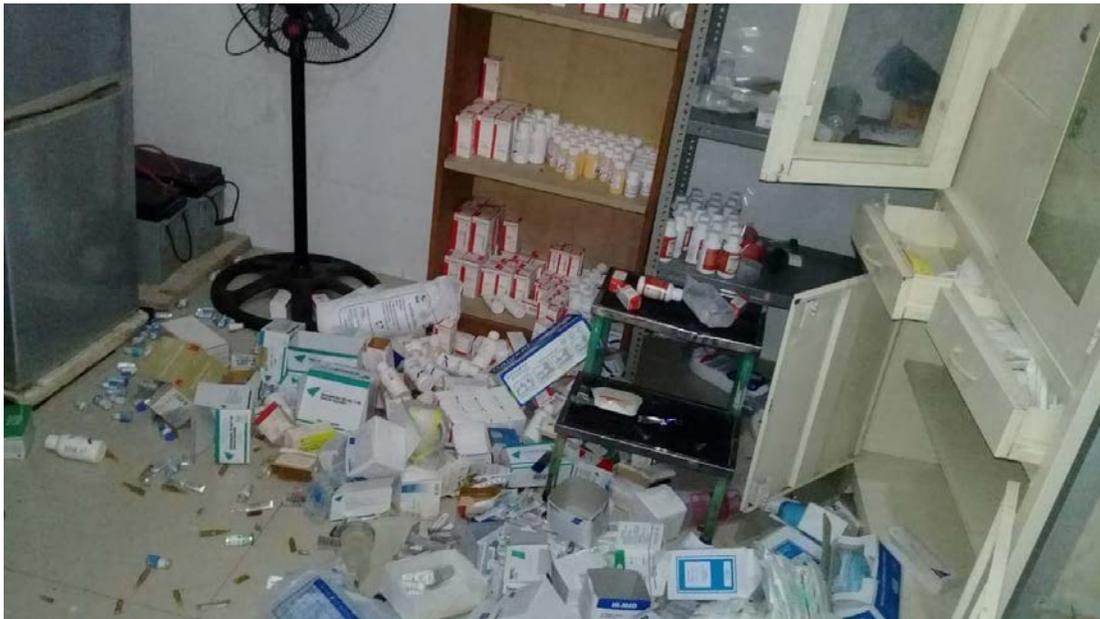
medicines placed on shelves toppled by the high lateral accelerations as shown in Figure 9.79, while Figure 9.80 displays medicine contents overturned by the high lateral accelerations.

Figure 9.80. Medicine contents overturned by ground motions at Huatapi, from Capelo district, Requena province (Loreto) (Source: Rotafono [2]).
